## STUDIES AND RESEARCH ON DETERMINING THE CAUSE OF THE CRACKING OF X60 PIPELINE IN THE EXPANDING OPERATION

**Stela CONSTANTINESCU**

"Dunarea de Jos" University of Galati, Faculty of Engineering, Romania  
e-mail: constantinescu\_stela@yahoo.com

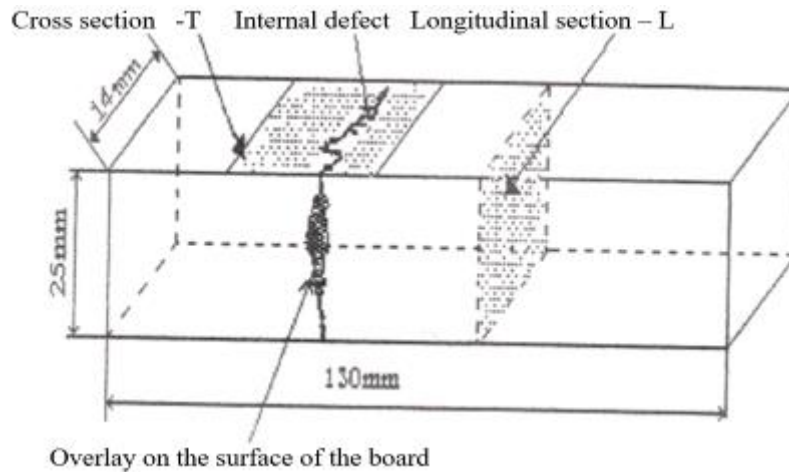
The analysis was carried out on a sample of the well-determined dimensions shown in Figure 1, the sample that comprises the defective area, was taken from a X60 fissured pipe to the expanding operation.

**Fig. 1.** Location of the faulty area on the surface of the board and sections "T" and "L" analysed

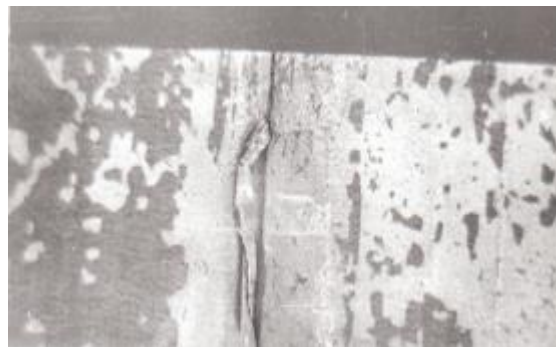
On the outer surface there is a longitudinal overlap of the material on the entire length of the sample (Figure 2).

**Fig. 2.** Macroscopic issues. Surface of the board-presence of the overlap of material x1,4

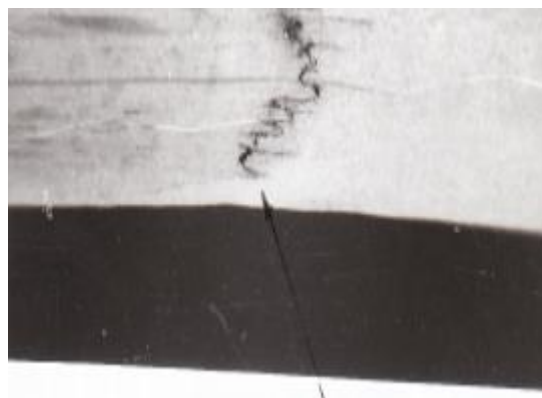
The cross section shows, starting from the longitudinal overlay, the zigzag fissure developed, in

the analysed plan, on approx. 90% of the thickness of the board. The macroscopic attack with hydrochloric acid indicates linear chemical segregations of different lengths (in the centre of the thickness of the linear segregation table occupying virtually all the length of the sample). The dark aspect of linear segregations indicates the existence of higher carbon content in these areas (Figure 3).

**Fig. 3.** Macroscopic issues. Cross section "T" – Fissure area x 1,4

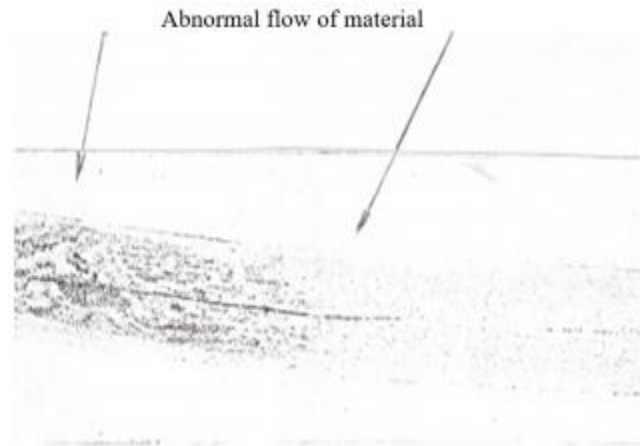
The Baumann footprint performed in the cross section of the board indicates a non-uniform distribution of sulphur. There is a higher

concentration in sulphur on half a sample, which also comprises an area with an abnormal flow of material. In the central area of the thickness of the board is observed a linear segregation in sulphur, on almost the entire length of the cross section (Figure 4).

**Fig. 4.** Macroscopic issues. Segregation in sulphur – the footprint of Baumann

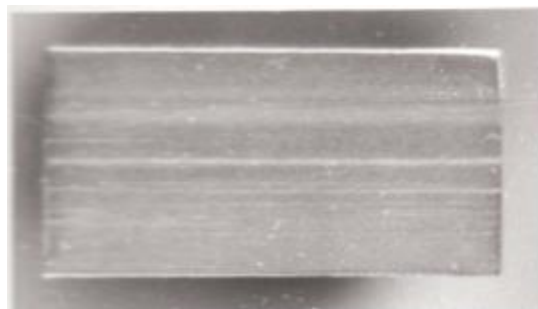
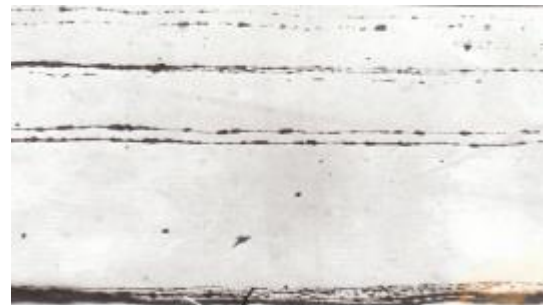
**Fig. 5.** Aspects of steel purity. Longitudinal section "L"

The aspects of purity steel were made in macroscopic and microscopic evidence in the

longitudinal section "L". It has been found to have macroscopic inclusions that affect virtually all the thickness of the tablet, in the analysed plan. Recorded macroscopic inclusions are of silicates fragile type (Figure 5).

a) aspect macroscopic x3

b) Microscopic appearance x100

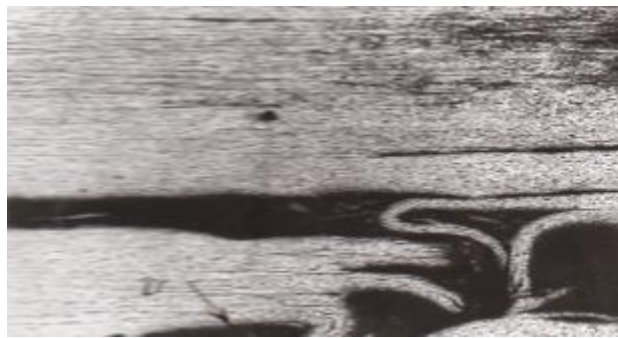
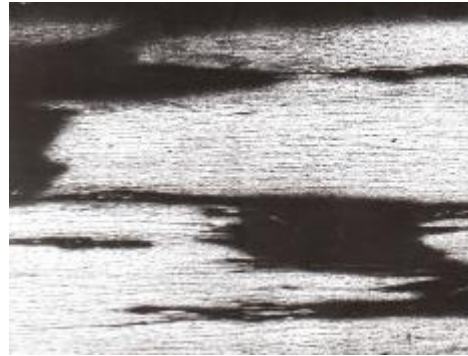
**Fig. 6.** Structural aspects of the section of the board. Cross section "T"

It was found that at approx. 5 mm of the outer surface of the Board (in the outer overlay area), on the transverse rift, the normal flow of the material to the hot deformation was prevented by the presence of foreign particles. These particles still retain the hardening structure, not removed by hot lamination of

the board, due to its characteristics different from those of steel. (Figure 6 - detail D).

The steel structure has a strong character in the strings due to the primary segregation in Sulphur and phosphorus, accompanied by the presence of non-metallic inclusions. There were also registered as structural defects, bands having the width of 0.4-1.5 mm in which the larger quantity of Perlite indicated a higher carbon content (segregation area in carbon).

a) macroscopic structure x32

b) microscopic structure x320 (detail in area D)
