THE EXPERIMENTAL ANALYSIS REGARDING THE EVOLUTION OF SOME MECHANICAL CHARACTERISTICS FOR A STEEL USED IN CONSTRUCTIONS OF CONDUITS FOR STEAM TRANSFER

¹Dumitru MIHAI, ²Silviu MACUTA

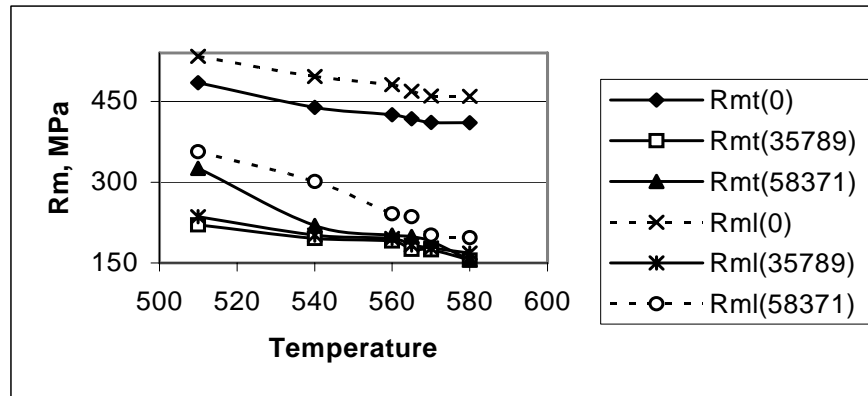
Fig.1. Evolution tendency of the ultimate stress with test temperature and functioning period

The study of the variations of the mechanical properties with temperature emphasizes that, as compared to the data found in standards, the material has a large reserve regarding the ultimate stress R_m .

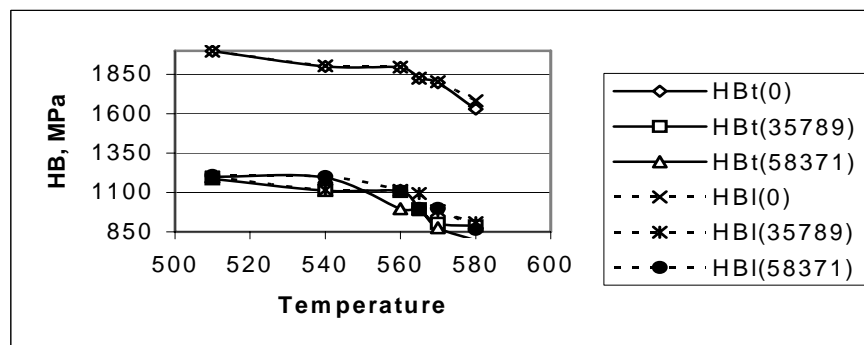
Fig.2. Evolution tendency of the yield stress with test temperature and functioning period
