FAILURE CASE STUDY SERIES PART ONE: ANALYSIS OF OXYGEN COMPRESSOR SHAFT BREAKAGE

Liviu GURĂU, Carmela GURĂU, Gheorghe GURĂU

Interdisciplinary Research Centre in the Field of Eco-Nano Technology and Advanced Materials CC-ITI,
Faculty of Engineering, "Dunarea de Jos" University of Galati, 47 Domneasca Street, 800008 Galati, Romania
e-mail: gheorghe.gurau@ugal.ro

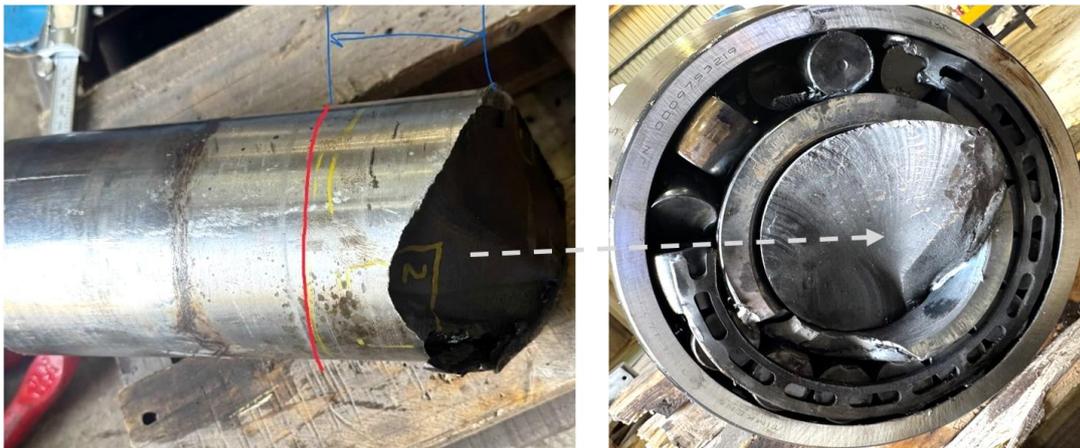
Fig. 1. The fracture surface

The images show a catastrophic shaft fracture near the bearing region. The fracture surface exhibits fatigue leading to catastrophic failure. The bearing shows complete structural failure, with the rolling elements deformed and displaced from their original positions.

The visual inspection indicates that the compressor shaft experienced a catastrophic fatigue fracture near the bearing and coupling region. The bearing adjacent to the fracture shows complete structural failure, with severe deformation and displacement of the bearing elements, implying a loss of internal alignment and a potential seizure.

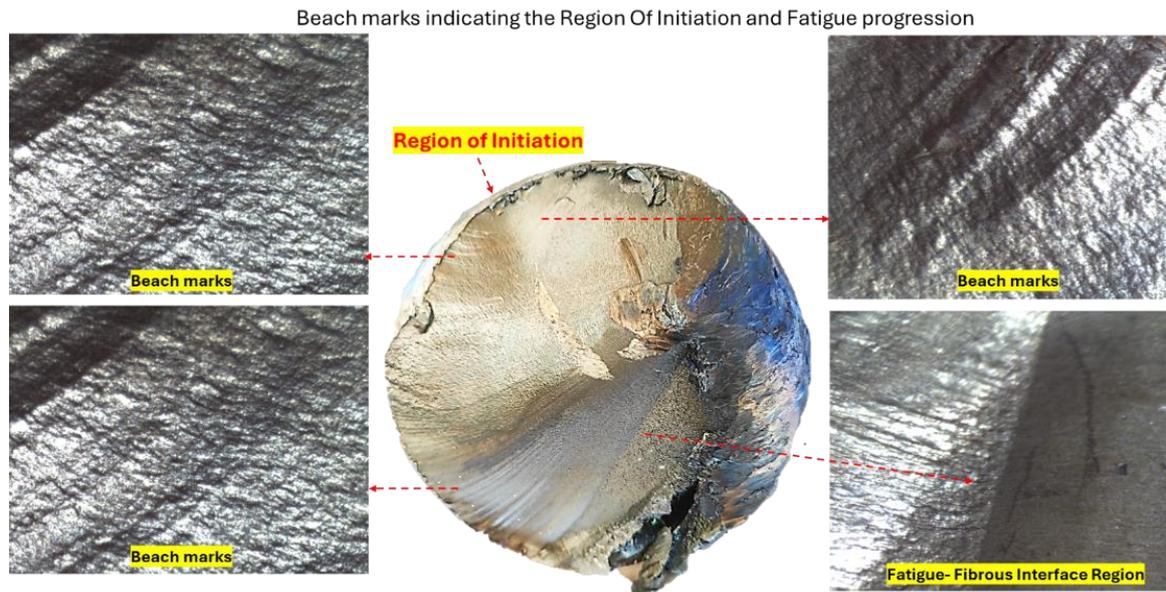
Fig. 2. Stereomicroscopy images on different zones on failure surface

The fracture surface indicates fatigue failure under bending stress. The crack initiated at the outer surface and propagated progressively, as evidenced by the concentric beach marks. The presence of a fibrous region signifies the rapid final fracture that occurred when the remaining cross-section could no longer sustain the applied load. The non-radial alignment of the fibrous region relative to the point of initiation further confirms asymmetric bending - rather than symmetric stress - as the dominant loading condition. Overall, the observed features - initiation site, beach marks, and final rupture are fully consistent with a fatigue-induced fracture mechanism under cyclic bending.

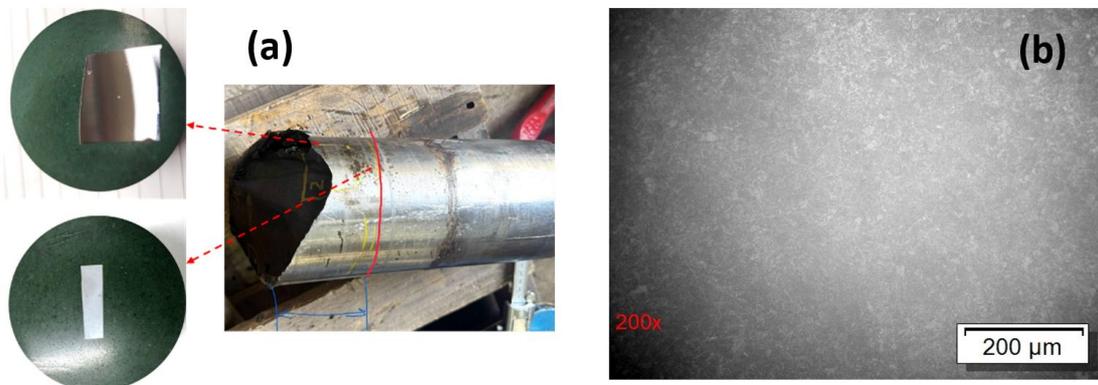
Fig. 3. Cross-sectional samples (a), ferrite-pearlite structure

Figure 3b points out a homogenous, fine ferrite-pearlite structure.

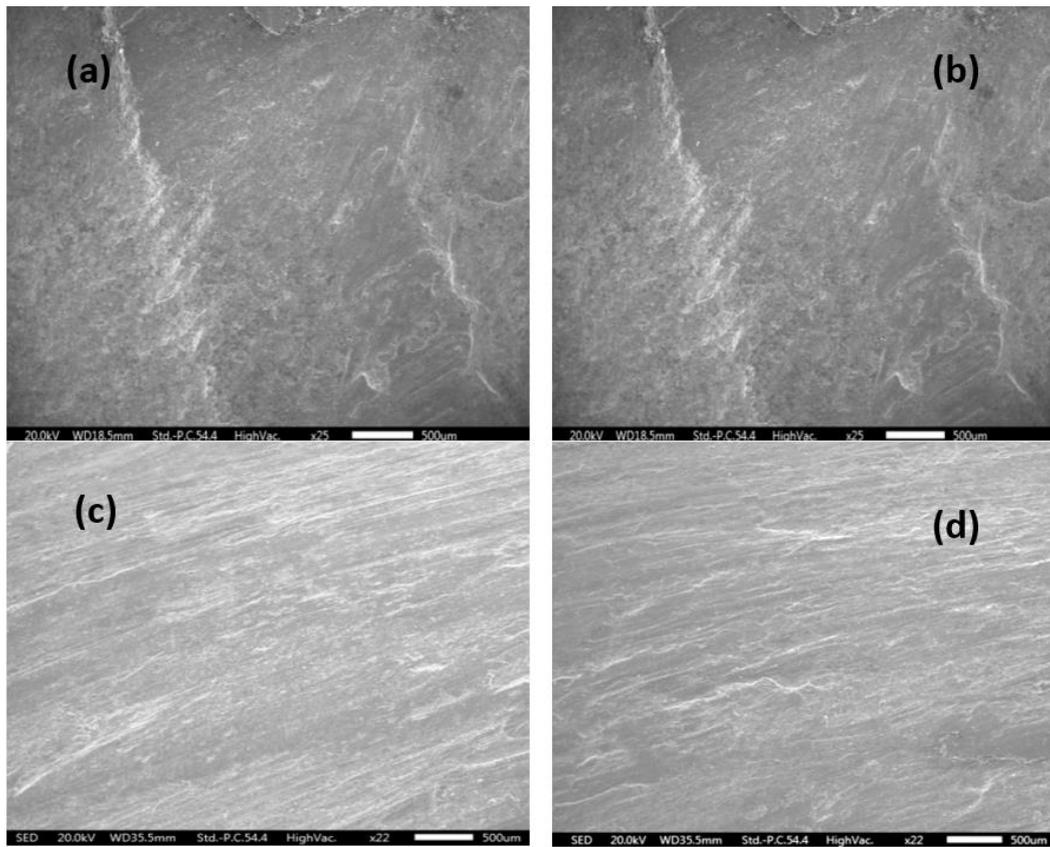
Fig. 4. SEM micrographs

Ratchet marks were observed that indicate multiple crack planes merging with one another (Figure 4a and b). Moreover, Figure 4c and d show multiple striation indicating progressive fatigue crack growth under cyclic loading.

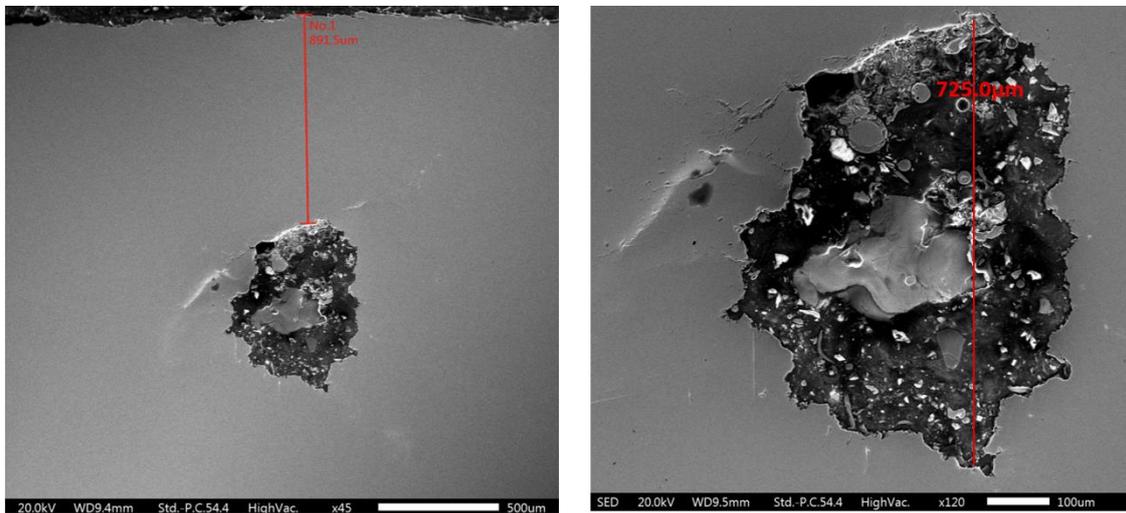
Fig. 5. SEM micrographs - exogenous inclusion

On further examination, we can observe a coarse exogenous inclusion (0.72 mm) at a depth of 0.80 mm from the surface, located precisely at the region of crack initiation. This inclusion likely acted as a stress concentrator, contributing to the onset of fatigue failure.

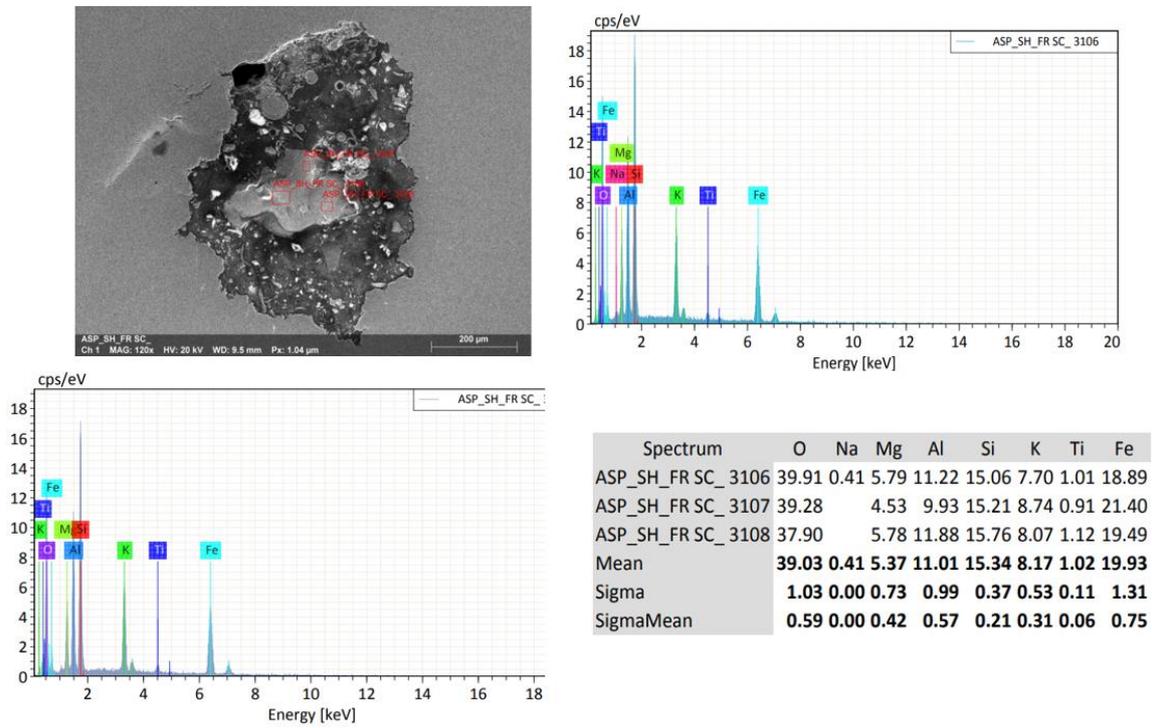
Fig. 6. EDS spectra

EDS analysis reveals that the inclusion is primarily composed of O, Al, Si, and Fe, indicating an oxide-based inclusion, likely aluminosilicate in nature. Such inclusions can act as stress concentrators

and contribute to crack initiation at the fracture surface.

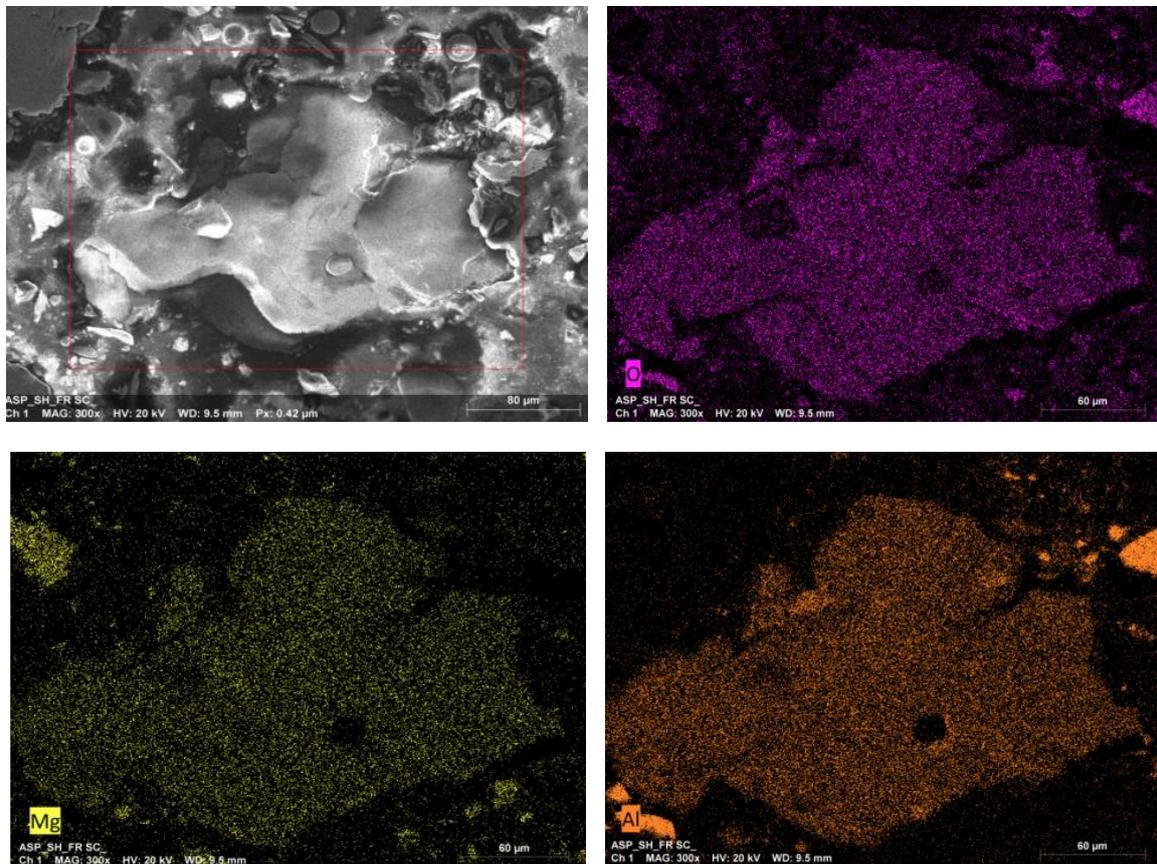
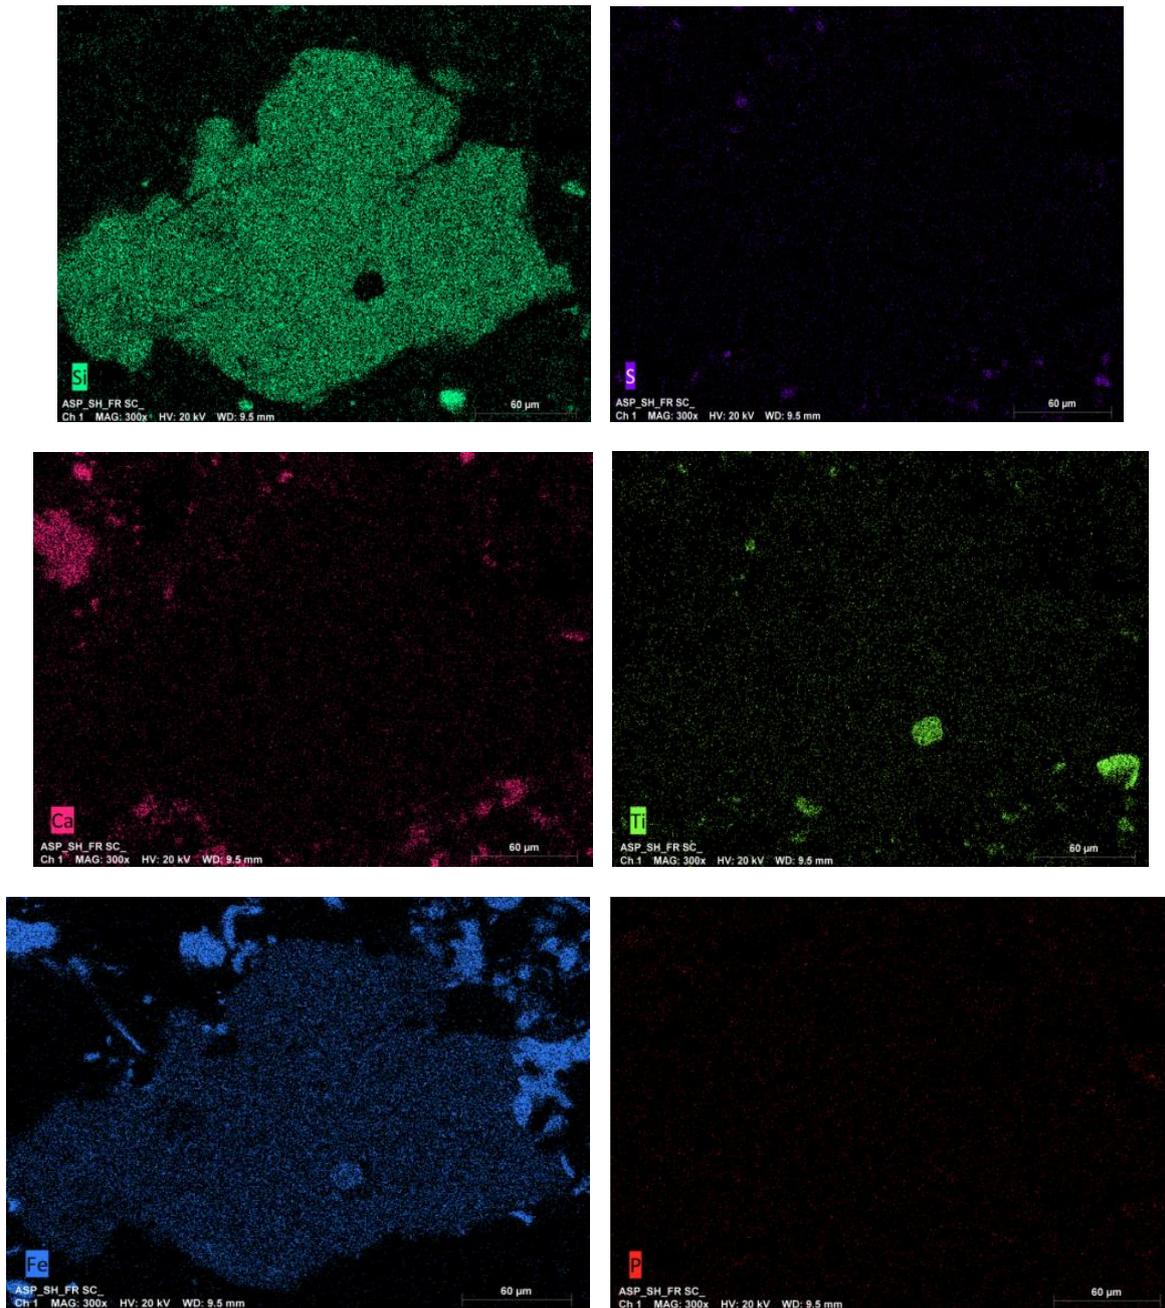
Fig. 7. Elemental mapping (SEM)

Elemental mapping (Figure 7) confirmed that the complex oxide inclusion comprises predominantly of Al, Mg, and Si.

SEM-EDS and elemental mapping revealed coarse, complex oxide inclusions (0.72 mm) at the region of initiation.
