## INVESTIGATIONS ON WIND TURBINE BLADES DEGRADATION

Romeo MARIN, Valentin AMORTILĂ,  
Costel HUMELNICU

”Dunarea de jos”University of Galati, Faculty of Engineering, Romania

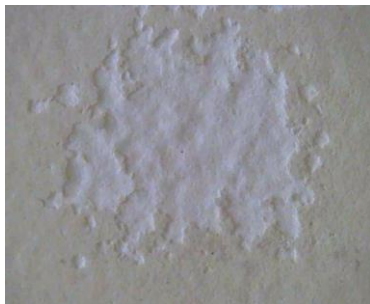
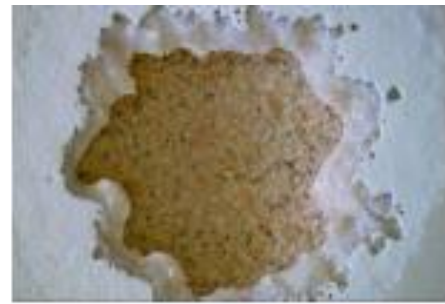
Fig. 3. Samples' degradation

observations can be made. Figure 3 shows the image of damaged areas obtained with the exposing time increasing from 15 s to 180 s.

As one can see, there are several stages of degradation, following the exposure time to the abrasive agent. Figure 4a presents the damaged area obtained after 15 s testing time, while Figure 4b shows the corresponding cross-section of the area. In this case, the top layer of the blade is damaged, but not penetrated, the maximum depth of the scars being 0.35 mm.

a) initial degradation (15 s); b) medium degradation (160 s); c) advanced degradation (180 s)

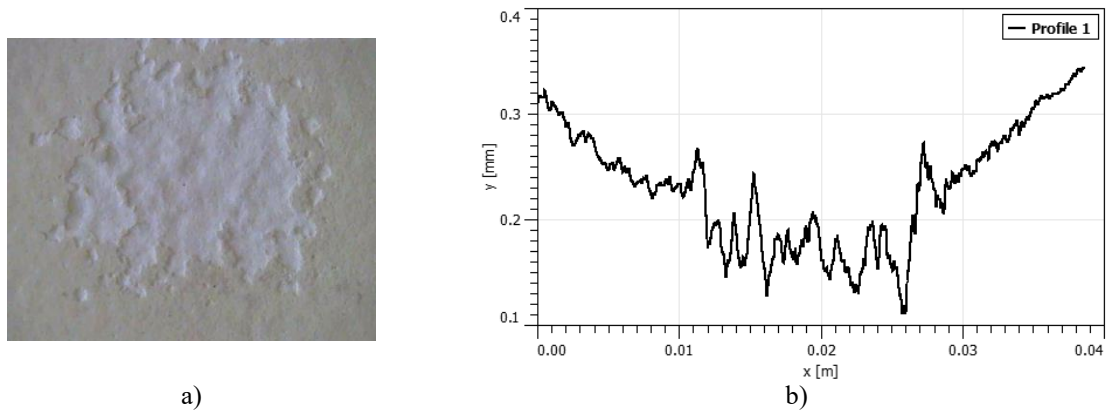
Fig. 4. Image of damaged area of the blade material tested for 15 s testing time  
a) top view; b) cross-section of the damaged surface

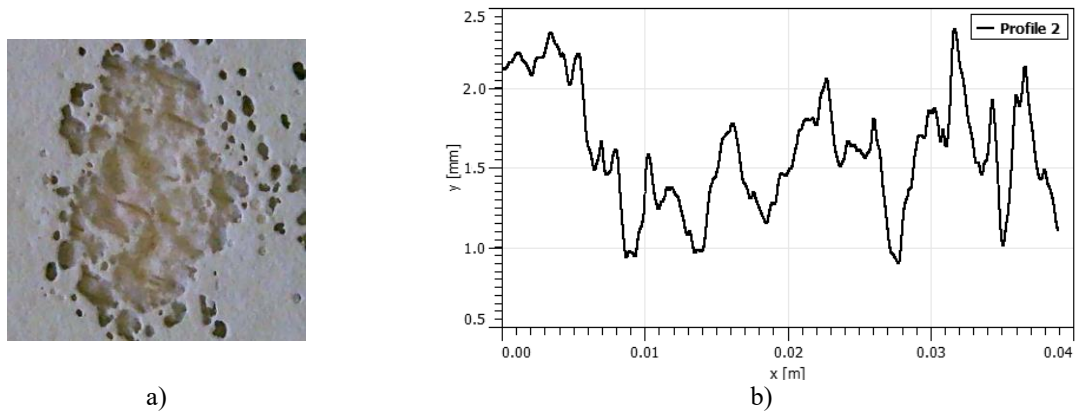
Fig. 5. Image of damaged area of the blade material for 160 s testing time  
a) top view; b) cross-section of the damaged surface

Increasing the exposure time to 160 s, the maximum depth of the damaged area is increased (Fig. 5a) and, also, the depth showing a maximum value of 1.6 mm. In this case the top layer is penetrated (Fig. 5b) and, in some areas, the glass fiber fabric is also damaged.

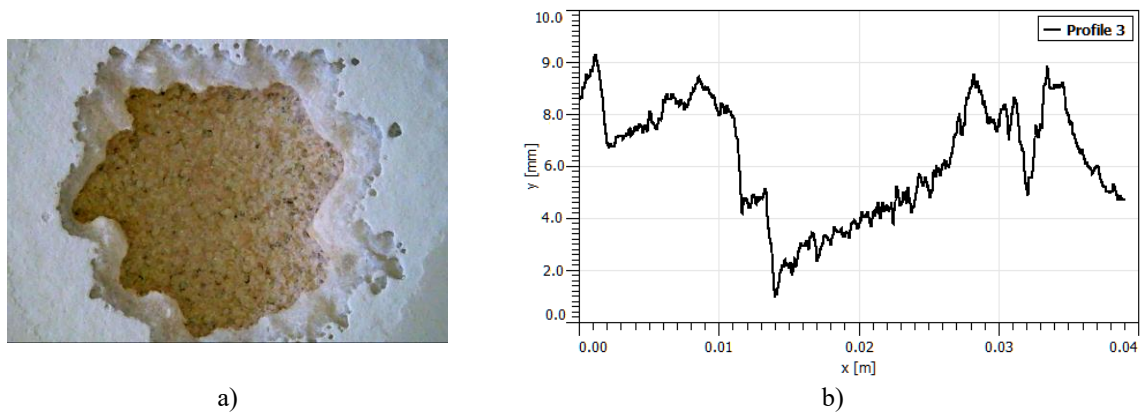
Fig. 6. Image of damaged area of the blade material for 180 s testing time  
a) top view; b) cross-section view

If the top and glass fibers layers are penetrated, the internal layer is exposed to the direct action of the abrasive agent, leading to a rapid increase of the degradation. If the time necessary to penetrate the first two layers is approximately 160 s, the internal layer is destroyed in approximately 20 s, the degradation

depth reaching 8.6 mm (Fig. 6).

In Figure 6a, it can also be observed the pattern of the degradation. Taking into account that the abrasive particles have different weights and the air stream have a conical shape, the corresponding impact energies are different, leading to uneven damaged area. In the middle, all layers are penetrated, meanwhile near the borders, only the first two layers are damaged, as it can be observed in figure 6a.

The tests' results shown that the most resistant to the abrasive agents is the top layer, the next two layers being more sensitive to the erosive action. If the top layer is penetrated, the degradation become rapidly catastrophic, leading to the removal of an important quantity of material from the blade.
