INFLUENCE OF COOLING OIL ON THE SURFACE QUALITY OF THE ROLLED STRIP

Tamara RADU, Stela CONSTANTINESCU, Florentina POTECAȘU

"Dunarea de Jos" University of Galati, Romania e-mail: tradu@ugal.ro

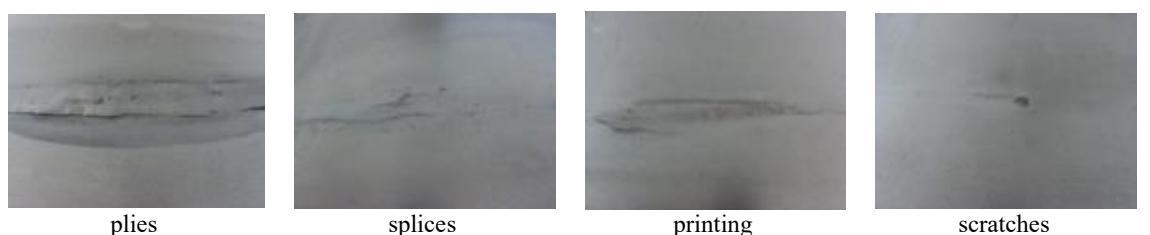
A primary cause of the occurrence of defects on the surface of very thin steel strips is the most common raw material. The identified raw material surface defects are: printing cylinder rolling folds of drawing up, scratches, splices (Fig. 1).

printing

scratches

Fig. 1. Raw material surface defects (x1/1)

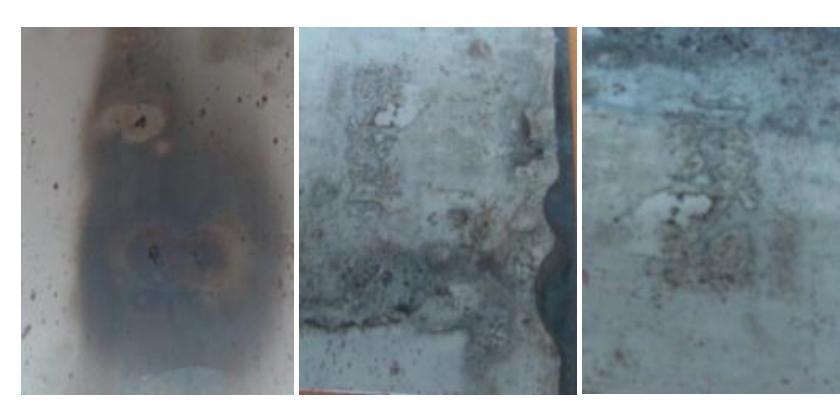
Fig. 3. Burned emulsion on the surface of the heat treated strip (x1/10)

The burned emulsion spots on the surface of the cold-rolled steel strip are caused by cracked emulsion residues from the thermal treatment of annealing. These residues are the result of unevaporated emulsion during annealing, which occurs due to an excess of emulsion on the cold rolled strip.

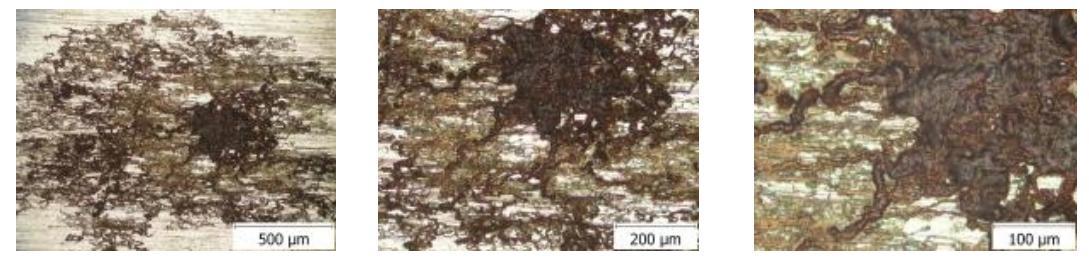
excess [10]. In Figure 4 it can be seen that the emulsion starts to stain a large drop that flowed on the surface of the steel forming radiating streams.

The spot droplet formed is dense and dark and the area where they spread is diffuse, without allowing compactness to reveal the steel bracket that appears white. At a magnification higher than 100, it can be seen that the core of started emulsion stain has also a heterogeneous structure showing black and gray burnt areas and less brown burnt areas. Large drops of emulsion are formed due to several causes.

Fig. 4. Formation of emulsion spots at different magnifications

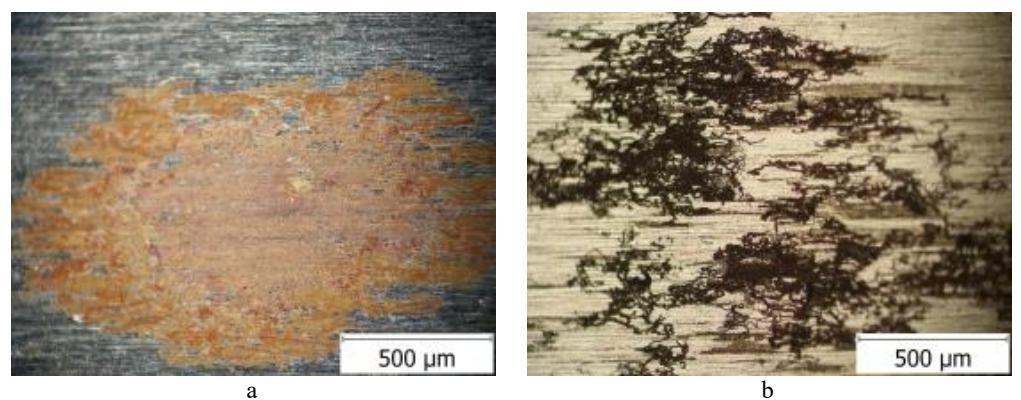
Emulsion spots are formed from singular and excessively high drops and will have nearly circular shapes (Fig. 5a). Burned emulsion spots come from several neighboring droplets whose small streams flow intertwined, forming less compact large spots (Fig. 5b).

Fig. 5. Aspects of burned emulsion spots *a* - compact spots; *b* - less compact spots

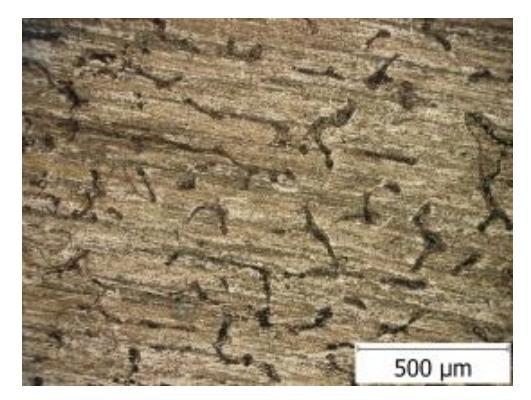
We also observed atypical distributions compared to those listed above, as shown in Figure 6. These spots, very diffuse and difficult to see with the naked eye, are formed from the excess of emulsion accumulated on bumps during the cold rolling process.

Fig. 6. Spots of burned emulsion with atypical forms

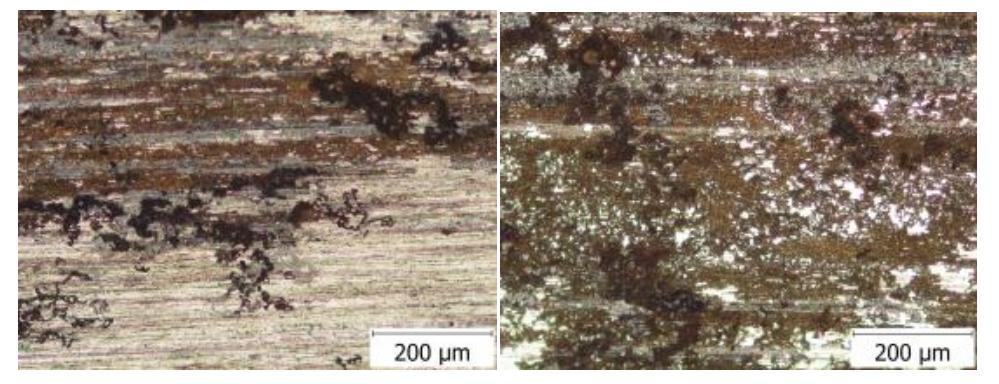
Figure 7 shows the structure of a burned emulsion spot with areas of corrosion of steel support

(rust) areas that formed carbon or combustion ash (light gray) and areas of black burned emulsion.

Fig. 7. Spot of burned emulsion with rust

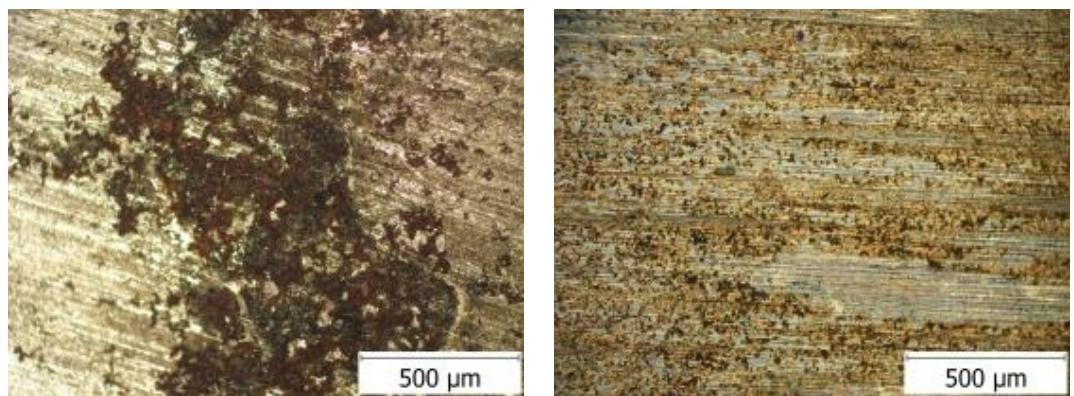
Emulsion spots intimately associated with rust are shown in Figure 8a. Corrosive attack with

singular formation of iron oxides in rolling direction can be seen in Figure 8b.

a. Emulsion spots intimately associated with rust

b. Corrosive attack in rolling direction

Fig. 8. Spot of burned emulsion with rust
