IMPORTANCE OF PERIODICAL EXAMINATION AND MAINTENANCE OF PROPELLERS FOR ENSURING SEA- WORTHINESS OF CARGO VESSELS

George Ciprian IATAN

Alexandru PASCU

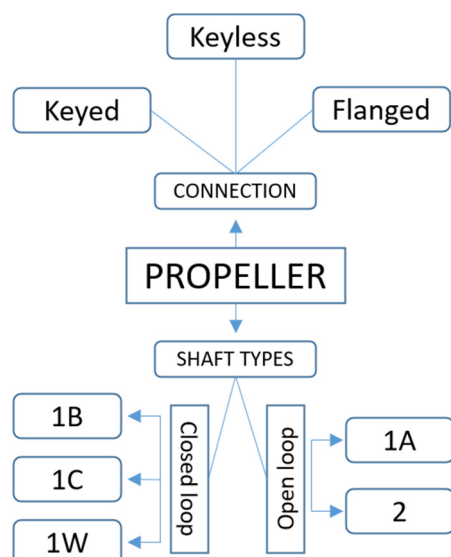
Figure 2 Propeller shaft and propeller connection types, adapted from ClassNK TEC-1277 [11]

According with the propeller connection type and lubrication method applied in the stern tube, one of the below mentioned propeller shaft surveys is to be regularly applied: Ordinary Survey/ Simplified Survey/ Simplified Partial Survey.[11]

It is noteworthy to highlight that Ordinary Survey is the most complex maintenance scheme and it involves complete extraction of the propeller and propeller shaft. Under normal operational condition, if chemical analysis of the lubrication oil is compliant with acceptable limits, wear down of propeller shaft bearing does not exceed 0.3 mm increment between two consecutive measurements and temperature records inside stern tube are not exceeding manufacturer indication [8], this maintenance scheme is applied once in 5 years for propeller shaft type 1A and once in 15 years for type 1B, 1C respectively 1W. However, it is acceptable to carry out tail shaft extraction once in 15 years, provided that Partial Survey with propeller removal is performed on 5 yearly bases, or at least Simplified Partial Survey is attained [11].

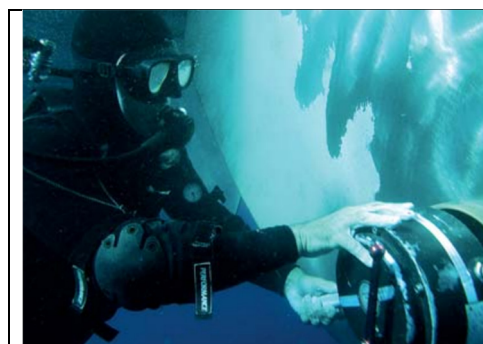
Figure 3 Underwater mechanical polishing on NAB propeller of biofouling, during in water survey [14]

performed for the propeller, exposed part of stern tube bush, sealing glands, fastenings and clearances.[12] Of particular importance is the surface of the propeller. Although most of the commercial vessels are equipped with Nickel Aluminium Bronze (NAB) propeller, material with augmented performance in the harsh marine environment due to its commendable corrosion and wear resistance [15], propellers are still prone to biofouling attachments. Under this unwanted reality, propeller efficiency is adversely affected. Starting from the surface roughness determined by the barnacle adhesion, Wang et al. performed CDF numerical simulation in order to evaluate the negative impact. Though, it has been noticed that flow separation and horseshoe vortices appear on the surface contaminated with biofouling, leading to a decrease of the propeller efficiency up to 40%.[13] To efficiently counter the deleterious effect of barnacles upon the hydrodynamic efficiency of the propeller, maintenance works are carried out during periodical surveys by mechanical polishing of the blades surfaces, as highlighted in figure 3.

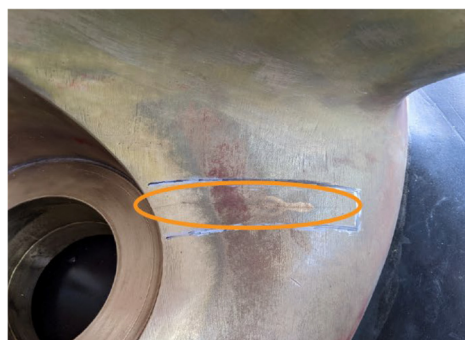
a) Surface cracks on blade no 2

Figure 7 Propeller failure due to cracks, as reported by investigation assessment [23]

system. Despite the best efforts of the crew, situation could not be rectified on board and vessel commenced dry dock for evaluation of damages and restoration of the system. However, during close up examination of the propeller in dry dock, it has been ascertained by the responsible Classification Society and Coast Guard inspectors that leakages occurred because of fractures of the propeller material in the hub of two blades, in the vicinity of bolts, as depicted in below figure 6.

As a result of the investigation consisting in mechanical tests, chemical composition test and FEM simulation it was concluded that crack fracture occurred due to material high cycle fatigue and because of lack of meeting propeller manufacturer design specification for bolt hole counterbore radius. [23]
