ANALYSIS OF THE FLOODS EFFECTS IN JUNE 2016 IN THE VORONET RIVER HYDROGRAPHIC BASIN

Mihail LUCA, Mihaela AVRAM, Nicolae MARCOIE

"Gheorghe Asachi" Technical University of Iasi, 63 Mangeron Dumitru Street, 770800, Iasi
e-mail: mluca2004@yahoo.com

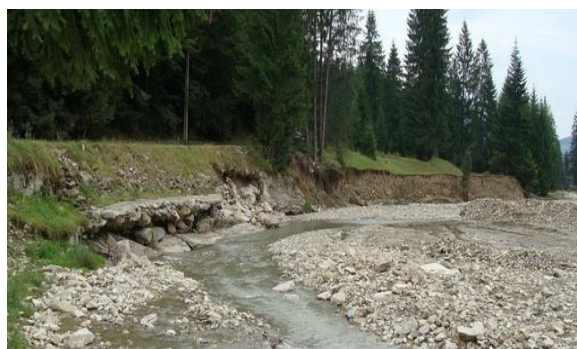
Fig. 5. General view of the Voroneț River shore erosion at the limit of the road DJ 177D in the downstream area after the flood of June 2016 (photo Aug. 2016 [4])

- structural degradation of the county road DJ 177D on a length of 1500 m and breaking it on a length of 400 m (Figure 5 and 6);
- partial and total degradation of the bridges (5 bridges), of the footbridges (17 footbridges) and of the pedestrian bridges along the river's length affected by the flood;
- the degradation of shore defense works in urban and out-of-town areas;
- the erosion of the bank in urban and out-of-town areas, a situation that affected individual riverine properties;
- the morphological modification of the river bed by sectors, with the change of flow paths;
- material and human losses.

The river banks were eroded (2600 m of shore) and the bed was morphologically transformed (Figure 5) [4, 9].

The reduced dimensions of the Voroneț River flow section in the degradation area, as well as the absence of shore defense works, were the factors that allowed excessive road erosion. Old shore defense works have been degraded and no longer have a functional role in the transit of floods (Figure 5). The hydrodynamic erosion phenomenon of the bed has led to the lowering of the foundation quota of the shore defense constructions. The absence of rehabilitation works has led to a decrease in the protective capacity of shore defense works [3].

The reconstruction of the county road must be correlated with the design and execution of shore defense works on the affected river sector.

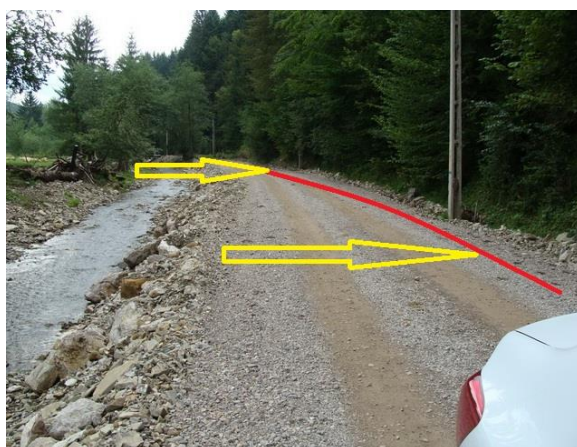
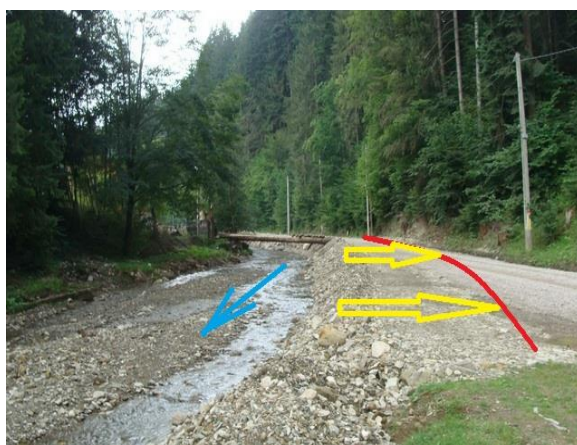
Fig. 6. Details of the Voroneț River's erosive action on the left bank and the road DJ 177D: a - the beginning of the deforestation degradation and the erosion of the road (downstream "Camp Cristea"); b - the end zone of the eroded road section to the slope (upstream of the Brusturosu Brook) [4]

The county road was degraded to a length of 1500 m. High intensity hydrodynamic erosion led to the degradation of the road 177 177D, until its total destruction over a length of 400 m (Figure 6). This situation caused the interruption of traffic over a period of time. The river advanced to the shore, then into the road until it touched the slope (Figure 6.a). The phenomenon has been accelerated by the river's curvature area, the absence of shore defense and the geotechnical constitution of the land.

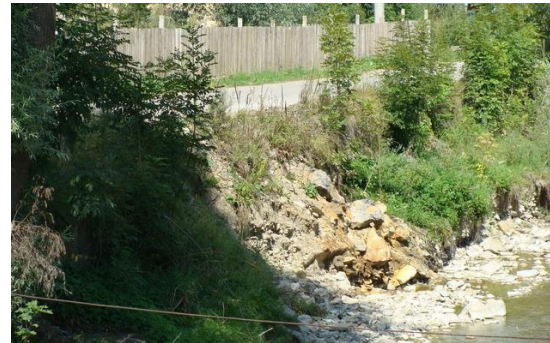
Fig. 7. Detail regarding the Voroneț River's erosive action on the river and the road in the Voroneț Monastery area [4]

The section of the riverbed in the area of the Voroneț Monastery has been affected by erosion phenomena, with an extension in the county road structure. Coastal defense works are degraded and aged without rehabilitation and upgrading. About 2.77 km of coastal defense were degraded by the flood of June 2016 [4].

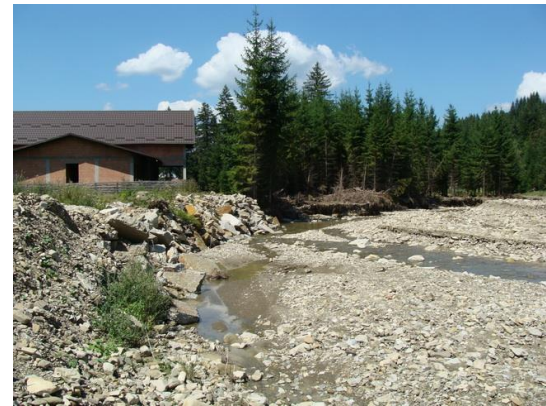
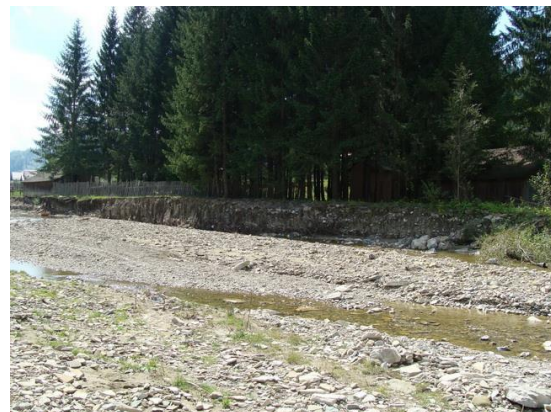
Fig. 8. Details of Voroneț erosive action on the riverbed and its impact on the riparian area: a - bank erosion and damage to a dwelling construction; b - morphological modification of the bedrock with excessive erosion of the left bank [4]

The degradation of the properties was favored by the non-observance of the law on the distances and the location of the constructions in the riparian area (Figure 8) [4].
