INVESTIGATION OF MECHANICAL PROPERTIES AND CORROSION BEHAVIOUR FOR 1010 CARBON STEEL PIPES USED FOR STEAM BOILERS

ABSTRACT

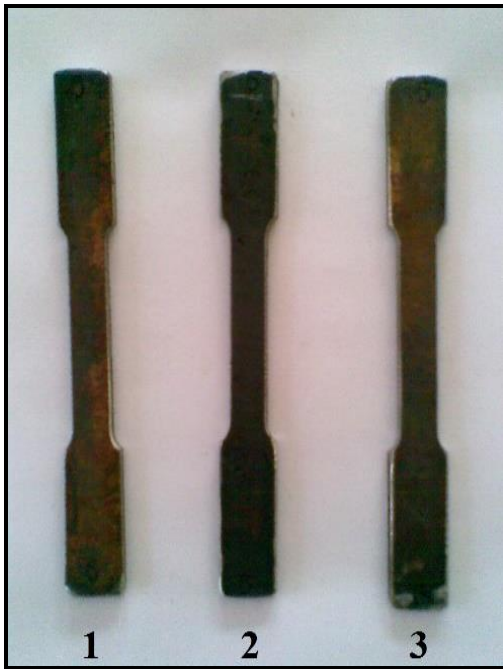
In Figure 2 the physical tensile specimens which were used in the research are presented.

Fig. 2. Macroscopic images of the 1010 samples used in the mechanical tests: 1) non-service specimen, 2) service horizontal boiler specimen and 3) service vertical boiler specimen

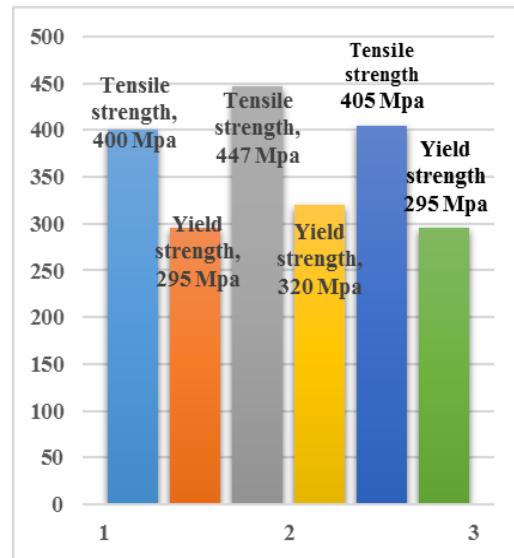
The Load - Displacement curves of the specimen are shown in Fig. 3 and the bar chart shown in Fig. 4 shows the comparison of the tensile parameters obtained from testing and the non-service specimen.

Fig. 4. The tensile strength and yield strength of the tested specimens: 1) non-service specimen, 2) horizontal boiler specimen and 3) vertical boiler specimen

It is noticed a decrease of mechanical properties (hardness and tensile stress) through the chart for both specimens. This makes the metal more susceptible to corrosion such as stress corrosion cracking and pitting corrosion under high temperature and high pressure. So, it is required a type of metal which has high mechanical properties to protect it from the corrosion.

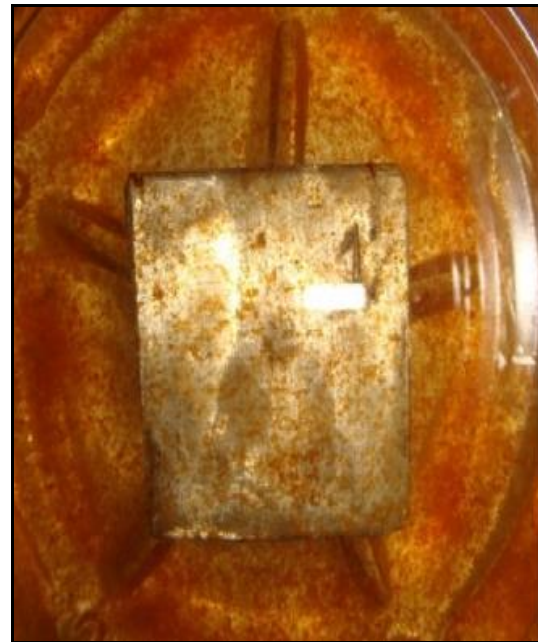
In Fig. 5 is presented a macroscopic image of a specimen used in the weight loss experiments.

Fig. 5. Macroscopic image of the tested specimen in the corrosive environment during the weight loss analysis
