## ANALYSIS OF THE PROPAGATION OF DEFECTS GENERATED BY THE OSCILLATION MARKS ON LAMINATED PRODUCTS

### ABSTRACT

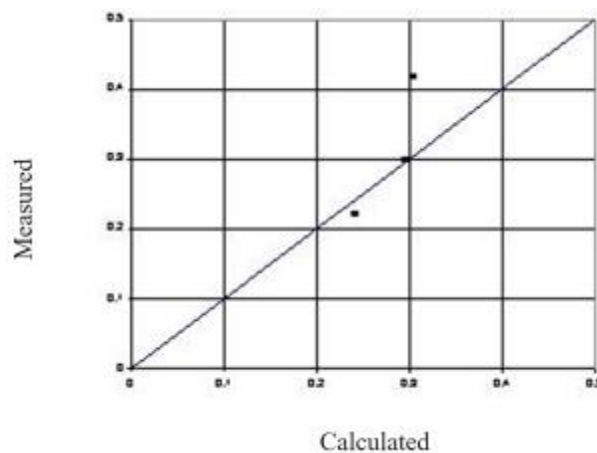
Figure 1 shows the correlation between the formula used for calculating the oscillation marks and the depth determined by microscope measurements.

**Fig. 1.** Comparison of calculated values with measured values for the depth of the oscillation marks

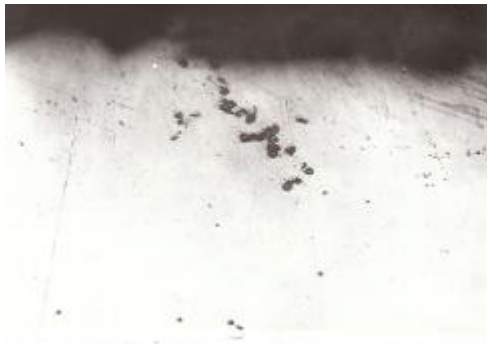
The purity analysis of all the samples in the area of the oscillating brands has emphasized, at charge 936884, the existence of the inclusion strings embedded in "hook" formed during negative stripping, in Figure 2 It is observed that the length of these strings does not exceed 100  $\mu\text{m}$ . This phenomenon is characteristic of the entire sample analysed.

**Fig. 2.** Non-metallic inclusions on the oscillation mark – charge 936884 – X250

Inclusions, especially exogenous ones, can be caught, now of negative stripping, in a subcutaneous area with a thickness of approx. 100 µm, as is apparent from the Figures 2 and 10.

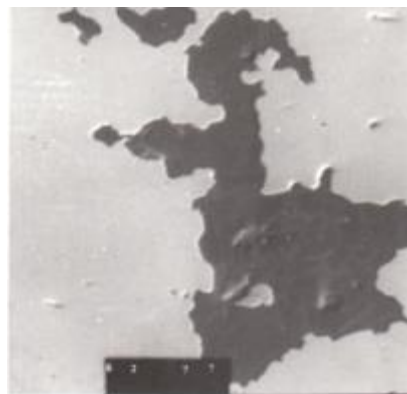
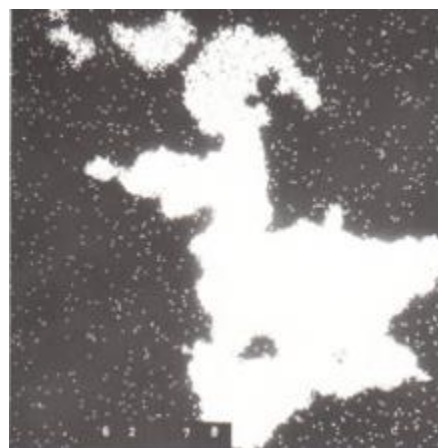
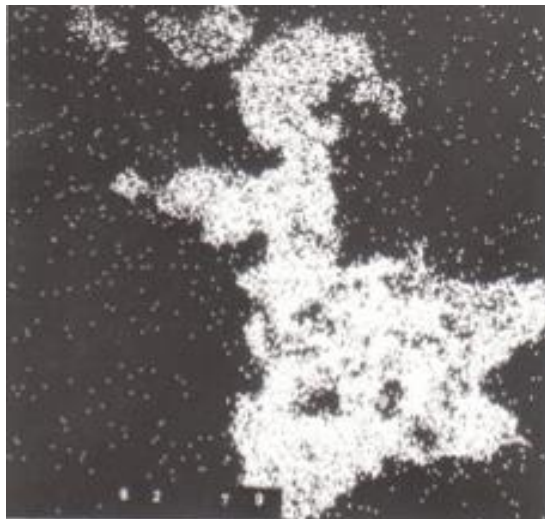
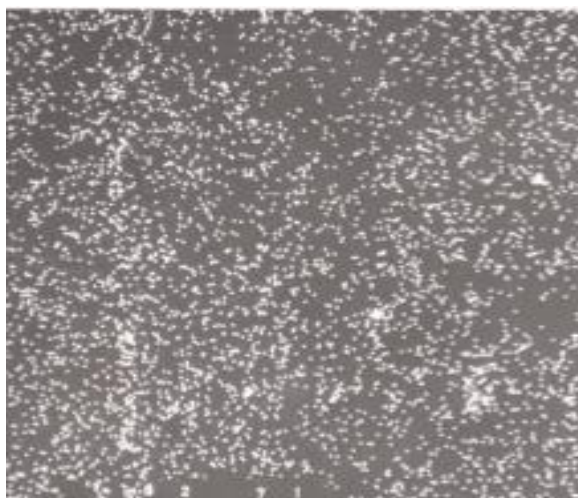
The microprobe analysis of these grouped inclusions has emphasized the following: the inclusions have an aluminum base component; the following components as weight are magnesium and calcium; silicon content does not differ from the value of the base material (the content of Si inclusion is close to that of the steel). The results of the analysis are presented in Figures 4-9.

**Fig. 4.** Composition image, X300

**Fig. 5.** Image of secondary electrons, X300

**Fig. 6.** Distribution Al, X300

*Fig. 7. Ca Distribution, X300*

*Fig. 8. Mg Distribution, X300*

*Fig. 9. Si Distribution, X300*

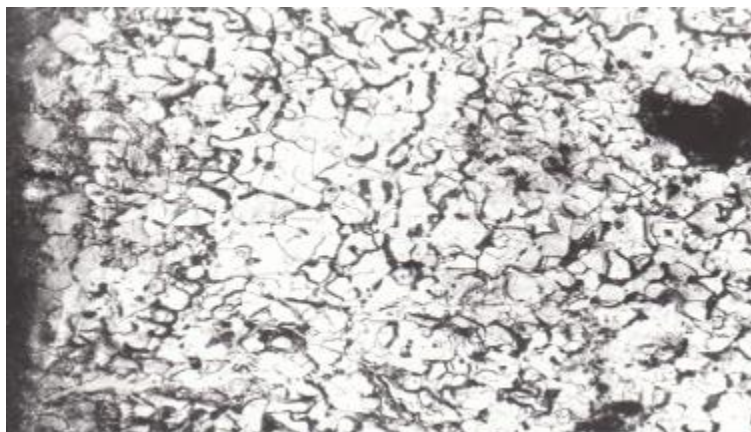
**Fig. 12.** Solidifying structure in the area of macroscopic inclusions - charge 936884 – X100

The analysis of the hardening structure in the area of the oscillating brands emphasized the following: at charge 936884 it was observed the presence of "hooks", Figure 10. At charge 923658 these "hooks" were virtually non-existent - Figure 11; Macroscopic inclusions analysed for charge 936884 9 (Fig. 3-9) were not retained by the deformation of the crust during the negative stripping, Figure 12.
