## NON-DESTRUCTIVE TESTING OF DUPLEX WELDING JOINTS

**Roxana-Alexandra GHEȚA, Maria-Cristina DIJMĂRESCU,  
 Laurenția BICHIR, Gabriel Marius DUMITRU**

### ABSTRACT

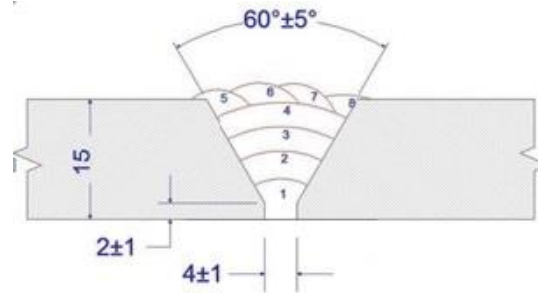
**Fig. 1.** The groove configuration and the layer layout 1÷8 - number of layers

The configuration of the chosen groove and the number of layers deposited are presented in Figure 1.

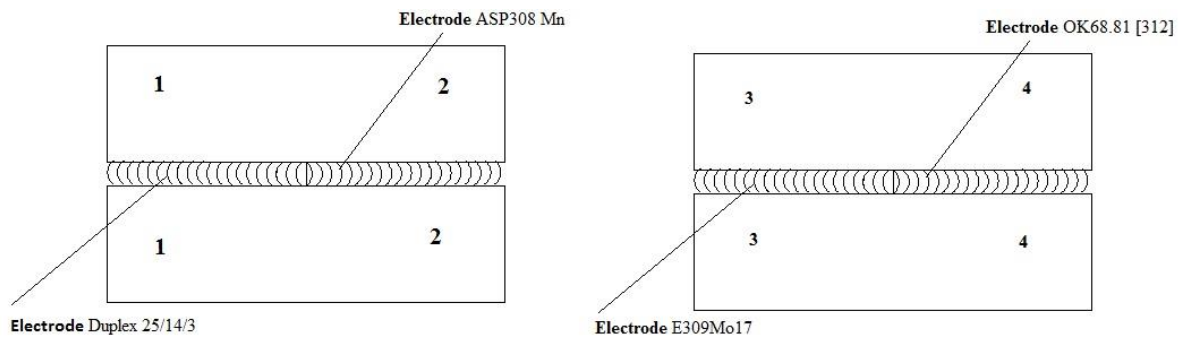
**Fig. 2.** Position of the electrodes used 1 - Duplex 25/14/3 electrode, 2 - ASP308 Mn electrode, 3 - E309Mo17 electrode, 4 - OK68.81 electrode

The samples were welded in horizontal position on each sample were used 2 types of electrodes as it can be seen in Figure 2.

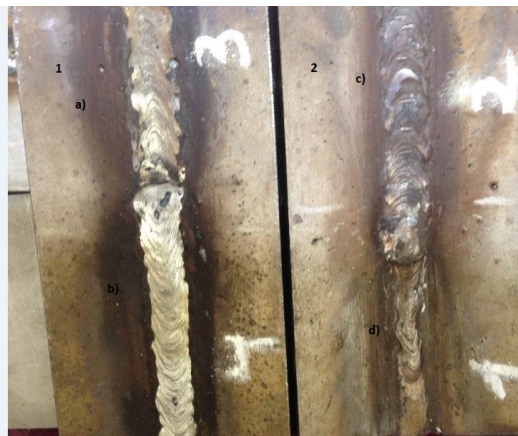
**Fig. 3.** Welded sample 1 - sample 1, a) - E309Mo17 electrode, b) - OK68.81 electrode  
 2 - sample 2, c) - ASP308 Mn electrode, d) - Duplex 25/14/3 electrode

The resulted welded samples are presented in Figure 3.

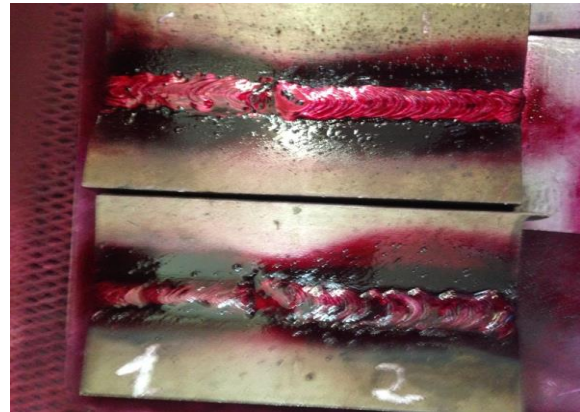
*Fig. 4. Penetrant Application*

- Penetrant application and dwell time - see Figure 4.
  - penetrant - METAFLUX 70-9802;
  - the penetrant was applied on the surface by spraying;
  - Dwell time – 10 min.

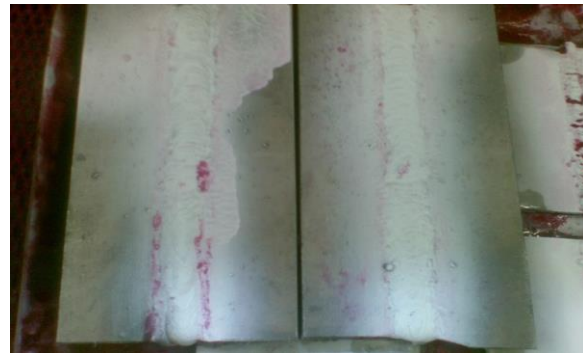
*Fig. 5. Developer Application*

- Excess penetrant removal – it was made by washing;
- Surface drying - it was forced by a hot air jet;
- Developer application – see Figure 5:
  - developer - METAFLUX 70-9803;

- the developer was applied in a uniform and thin layer, on the entire surface to be examined, only after having been well shaken beforehand;
  - after application of the developer, the examined surface was left to dry at room temperature;

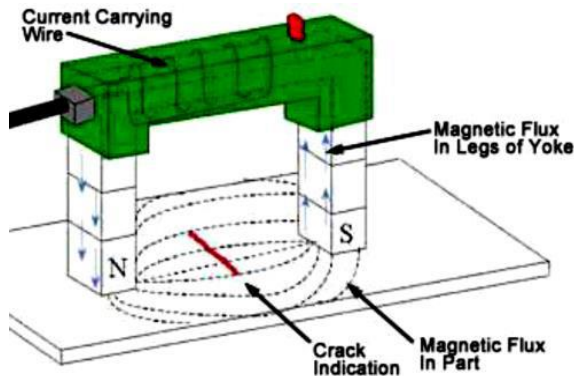
**Fig. 6.** The electromagnets - method principle

- Preparation of the test specimen - the samples were chemically cleaned by degreasing;
- Magnetization of the test specimen - it was conducted using electromagnets, as it can be seen in Figure 6. In the samples was created a longitudinal magnetic field composed by magnetic lines of force that run parallel to the long axis of the welded seam;
- Application of the magnetic powder – it was conducted using a suspension of fluorescent magnetic particles in low-viscos carrier oil with special additives PFINDER 150. With PFINDER 150 surface defects of materials can be indicated under UV-light. The suspension was applied on the surface by spraying;
- Viewing and recording of indications - The magnetic field was oriented so that its line of force was perpendicular to the maximum size of the imperfection, see Figure 7;

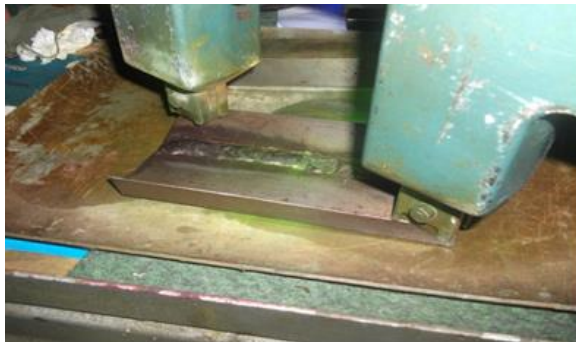
**Fig. 7.** Magnetization of the samples

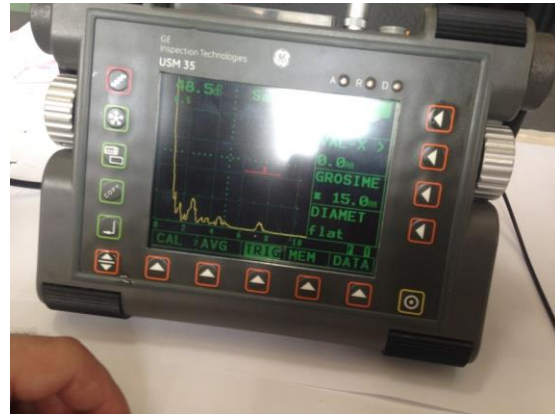
**Fig. 8.** Krautkramer USM-35 device

To conduct the examination, a Krautkramer USM-35 device was used, along with an angle beam transducer.

- Krautkramer USM-35 – see Figure 8;
- Angle beam transducer: 70° - AM4R-8x9-70;
- Calibration block used – A1;
- Couplant medium – grease;
- Frequency – 4 MHz.

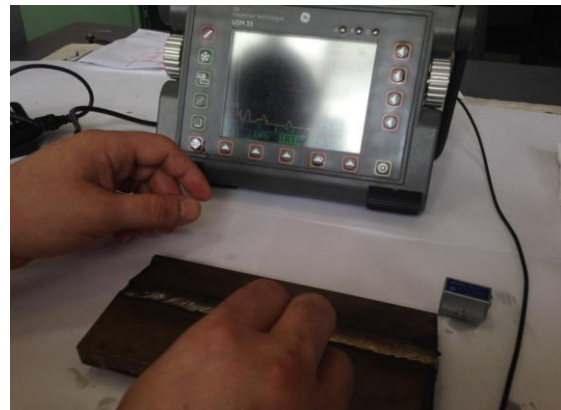
**Fig. 9.** Ultrasound examination

The ultrasound testing conducted on the samples is presented in Figure 9.

Using the ultrasound testing in sample 2, it was identified a lack of fusion between the root layer and second layer.

- The result obtained by Ultrasound Testing of the welded samples was inconclusive, obtaining only the identification of some big imperfections in the case of sample 2. Ultrasonic Testing of stainless steels is difficult due to the grain size of those steels.
