STRUCTURE EFFECTS OVER BEHAVIOR OF GRAPHITE GRAY IRON IN RUNNING

ABSTRACT

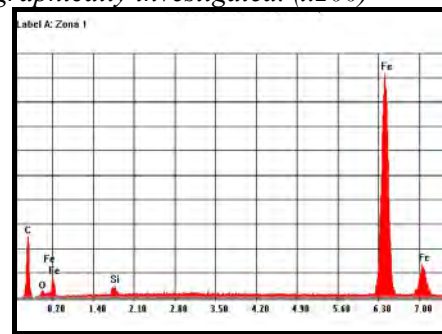
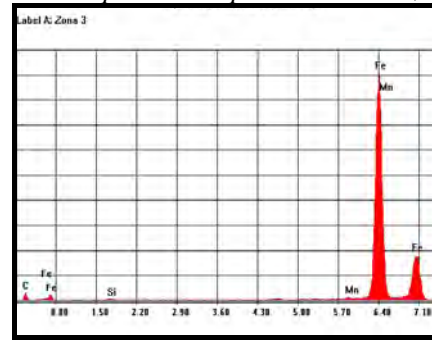
Fig.7. EDX spectrum- Specimen code 2.

Fig.8. EDX spectrum- Specimen code 3, area 1

Fig.9. EDX spectrum- Specimen code 3, area 2.

Fig.10. EDX spectrum- Specimen code 3, area 3.

In figures 7, 8, 9, 10 are shown the EDX specters of chemical elements in inter-dendrite areas oversaturated by impurities, for specimens code 2 and code 3.

Local distribution of chemical elements emphasizes several oxides and silicates present into the unpurified inter-dendrite areas of specimen code 2 and code 3 (fig. 7, 8, 9). It is noticed that crowds of oxides and exogenous inclusions (silicates) caused several lacks of composition (confirmed by the presence of antigratizant element Mn) that led to interrupting the

graftizing process over those areas (fig. 10).
