## SOME ASPECTS ABOUT THE REFRACTORY LINING WEAR IN FURNACES

**Tibor BEDÓ**

"Transilvania" University of Brasov  
email: [bedo.tibor@unitbv.ro](mailto:bedo.tibor@unitbv.ro)

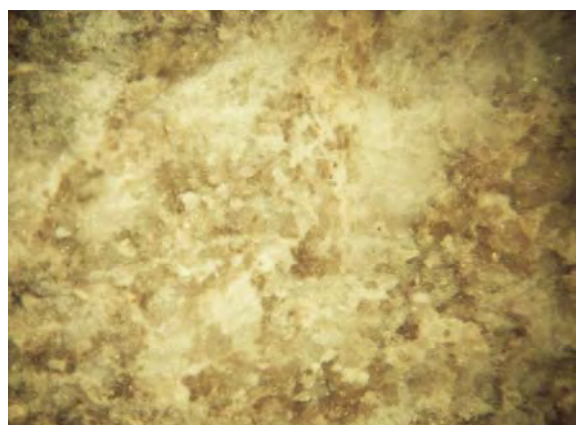
**Fig. 3.**  $\delta = 30$  mm from the lining – melt metal interface  
( $t < 1200$  °C; time = approx. 4 months)

The wear distribution way analysis on the wall thickness was made using a Silica Mix melting crucible from a coreless induction furnace employed to iron melting process approximately 4 months. The furnace inside temperature was 1450 °C. After the melting crucible replacement, by this was taken samples which were analyzed. The analysis was made at the lining – melt metal surface (fig. 1); at 10 mm inside from this surface (fig. 2); at 30 mm inside from this surface (fig. 3); at a half of refractory wall thickness (fig 4) and at the outside lining surface (fig. 5).

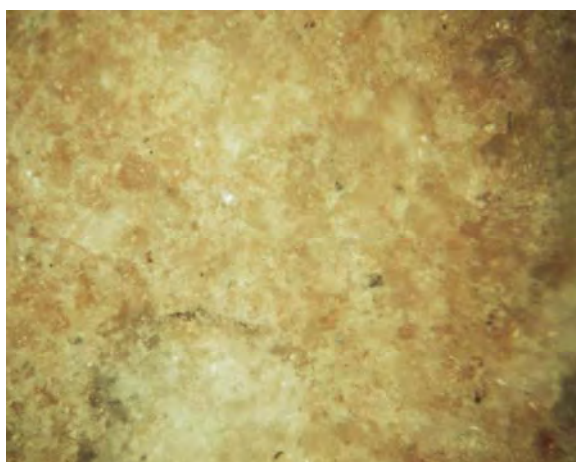
**Fig. 4.**  $\delta = 1/2$  of refractory wall thickness  
( $t \approx 700$  °C; time = approx. 4 months)
