RESEARCHES CONCERNING THE CONFIGURATION OF GEOTEXTILES IN THE EXECUTION OF REGULATORY WORKS IN THE RIVERBEDS

ABSTRACT

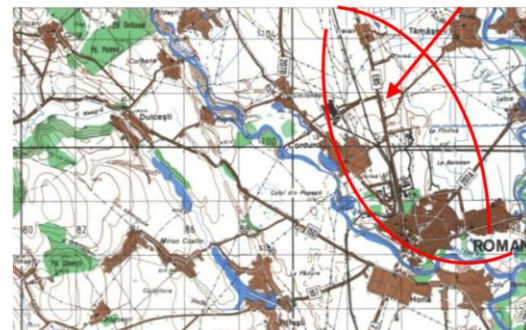
Fig. 3. Location of the research area 2, Pildești area, on the lower course of the Moldova River

The Moldova River presents in the research area a characteristic route of the lower course located in a low slope field area (Figure 3). The direction of flow of the river is NW - SE. The river Moldova presents the following characteristics up to the hydrometric station (SH) Tupilați: length - 176.60 km, surface of the river basin - 3951 km², slope - 1.30‰, average altitude - 236 m, average multiannual flow - 32.9 m³/s, solid flow in suspension - 43.2 Kg/s [11, 13].

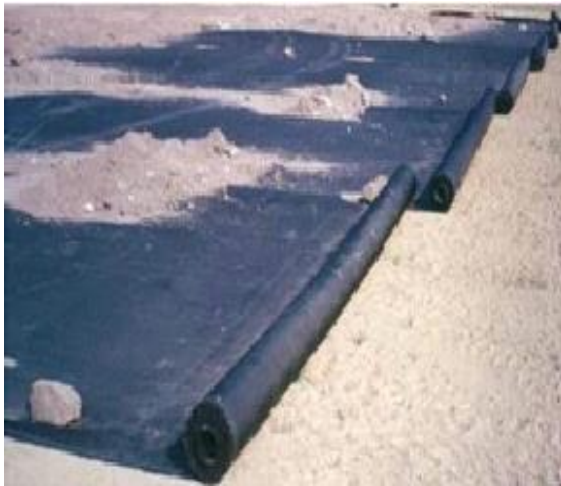
Fig. 4. Shore protection from non-woven geotextile mounted on the profiled slope of the river [10]

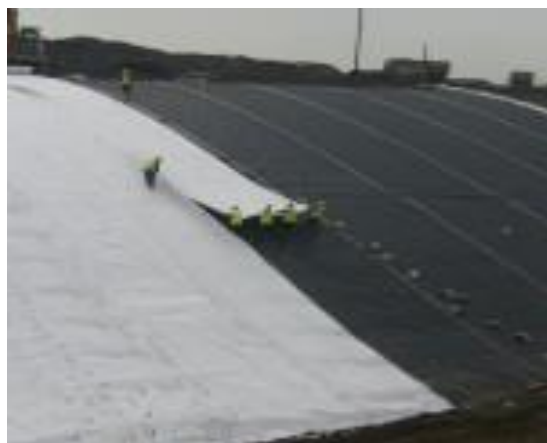
Fig. 5. Protection from geogrid + geotextile mounted on the profiled river bank [9]

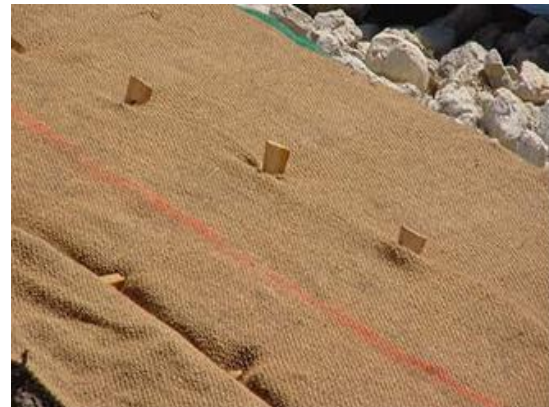
Fig. 6. Geotextile wool fabric mounted on the bank of a river as a support for the defence of the river [9]

The woollen fabric is geotextile made from natural, non-reinforced wool fibres, which are biologically degraded in about 2-3 years. Grass seeds are placed over the woollen fabric placed on the river bank, and above these a filling with vegetable soil is performed. By using this composite, the sliding planes on the slope are avoided and the conditions for the protection with vegetal layer are ensured.

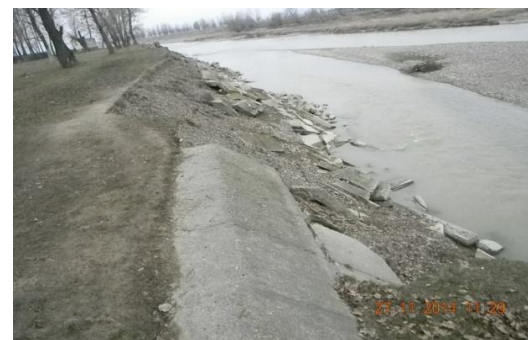
Between 2004 and 2012 there were a series of major floods on the river Moldova [4, 6], which partially and totally degraded the defences on some sections (Fig. 8.a).

Fig. 8. Shore protection in the Sochi area: degraded concrete slabs (year 2008) [4]; b - defence from geo-bags (photo Sion, 2019)

The technical expertise carried out in 2012 highlighted the state of degradation of the shore protection as a result of the action of water at floods, but also of the absence of maintenance works [4]. In 2015 the pipelines located in the subversion of the Moldova River were rehabilitated. Also, the shore

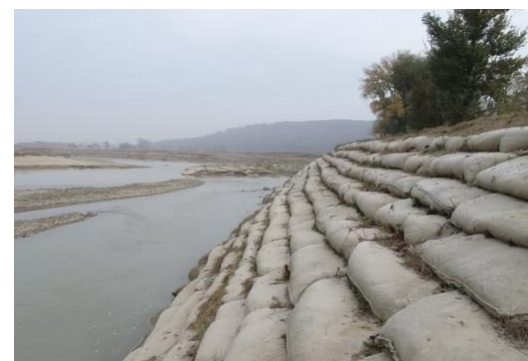
b

The shore defence is made of a structure of rectangular-shaped geotextile mattresses with a length of 1.50 m, width 0.80 m, height 30-40 cm and filled with ballast (Figure 8.b). The geotextile mattresses are placed with the long side parallel to the shore. Laying the mattresses horizontally was done in chess. Geo-bags in contact with water were filled with ballast mixed with cement [4].

- the shore defence behaved well in the action of the floods of 2016 and 2018, without showing significant degradation (Figure 8.b);
- a small number of geo-bags placed in the water contact layer were degraded by breaking down by the alluviums; the ruptures are in the direction of the water and have lengths of 3.0 - 8.0 cm;
- there was no movement of geo-bags vertically and horizontally.

defence was rehabilitated by using geo-bags as a solution to the instability of the foundation ground (Figure 8.b).

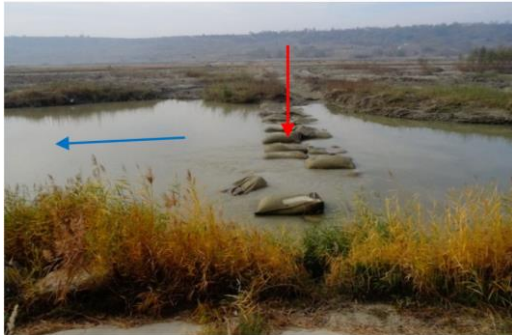
Fig. 11. Structural degradation of a bottom threshold made from geo-bags (photo, Sion, 2018)

- the degradation of the bottom thresholds by the hydrodynamic action is differentiated along the riverbed; degradation is manifested by moving geo-bags horizontally and vertically (Figure 11);

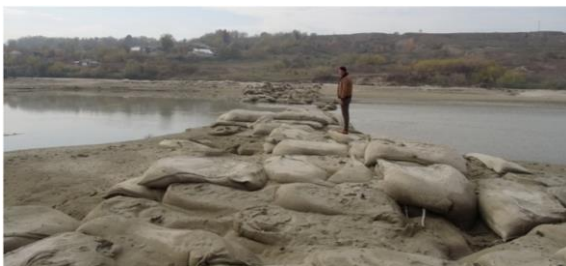
- some of the bottom thresholds analyzed were degraded by partially destroying a variable number of geo-bags and moving some downstream, or at the base of the threshold (Figure 12);

Fig. 12. General view of the structural degradation of a bottom threshold made from geo-bags under hydrodynamic action (photo, Sion, 2019)

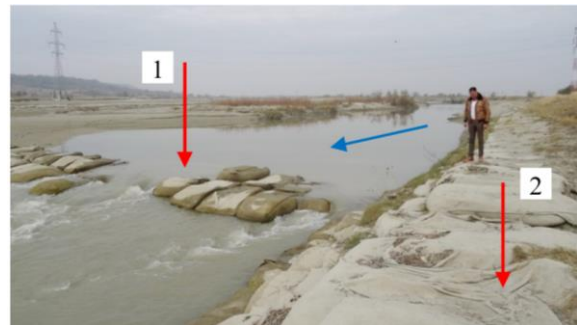
Fig. 13. Degradation of works from geo-bags on water action on the Moldova River: 1 - bottom threshold; 2 - shore defence (photo, Sion, 2019)

- the shore defence made from geo-bags is located at a variable distance from the old shore defence executed from concrete slabs (Figure 13 and 14);

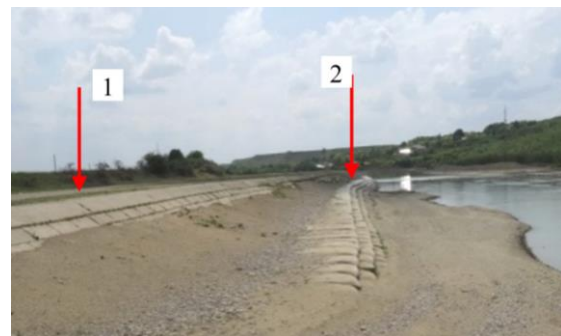
- shore protection from geo-bags is located at a variable distance from the old shore protection work carried out from concrete slabs (Figure 9, 13 and 14);

Fig. 14. General view of the left bank defence works: 1 - old concrete slab work; 2 - new work from geo-bags (photo, Sion, 2018)

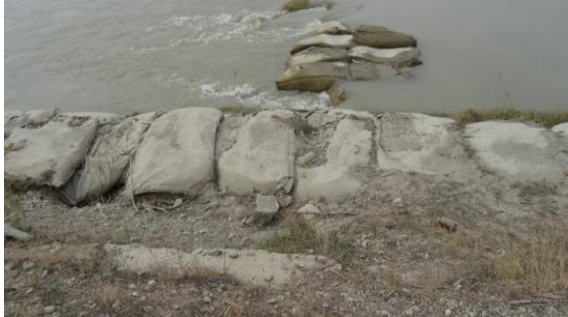
- a limited number of shore protection geo-bags are degraded by rupture as a result of flooding carried by floods (Figure 15);

- the analysis in the field showed that some of the geo-bags are degraded by local rupture and tearing by the flocks of sheep and goats passing through the shore area;

Fig. 15. Details on forms of degradation of geobags under natural and anthropic actions (photo, Sion, 2019)
