NON-DESTRUCTIVE TESTING OF DISSIMILAR WELDED JOINTS

This paper presents research's results of non-destructive examination of dissimilar welded samples. The samples were made using sheets of austenitic stainless steel and carbon steel welded through the method of MAG welding with tubular wire. The samples were subjected to non-destructive testing in order to analyse the integrity of the welded seam, heat affected zone and the adjacent area of the weld.

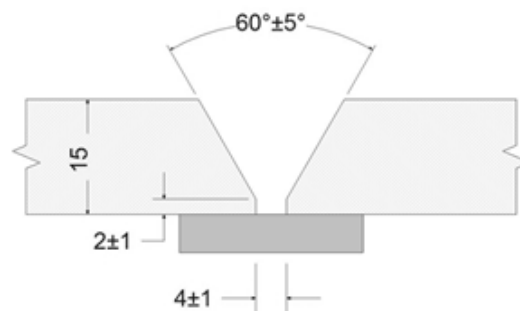
Fig. 1. The groove configuration and the positioning of the ceramic support

- The welding - The welding of the samples was conducted with a ceramic root using the MAG process. The groove configuration presented in Figure 1.

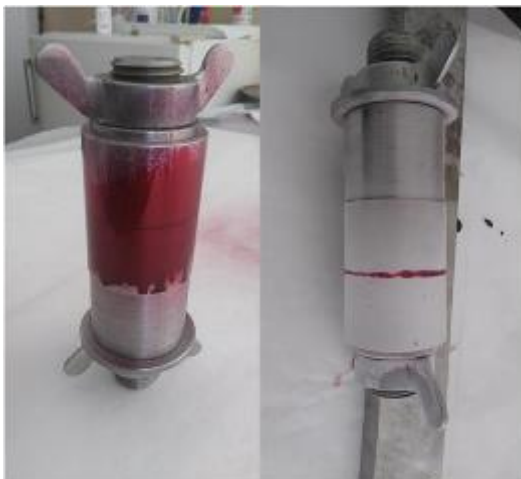
Fig. 2. Penetrant testing of the Miller etalon

For calculation of geometric sensitivity, the Miller etalon was used, see Figure 2. After the calculations, a geometric sensitivity of 0.965 was obtained.

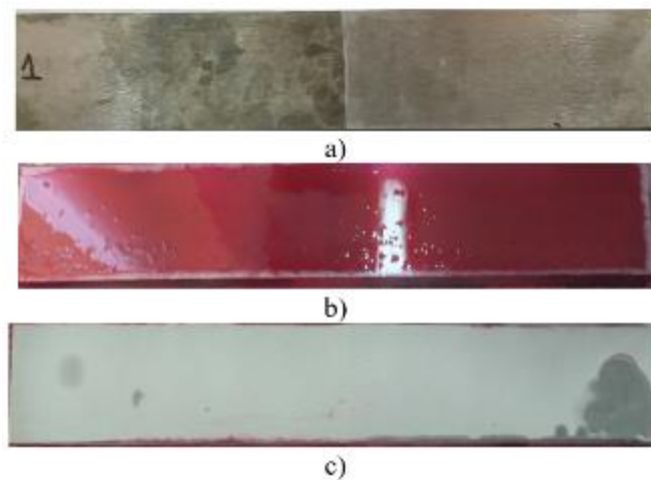
Fig. 4. Penetrant testing of the samples: a - test sample, b - application of the penetrant layer; c - the result obtained after drying by the developer

Upon examination with penetrating liquids, it was found that the piece had no detectable imperfections by this method on the surface under consideration.

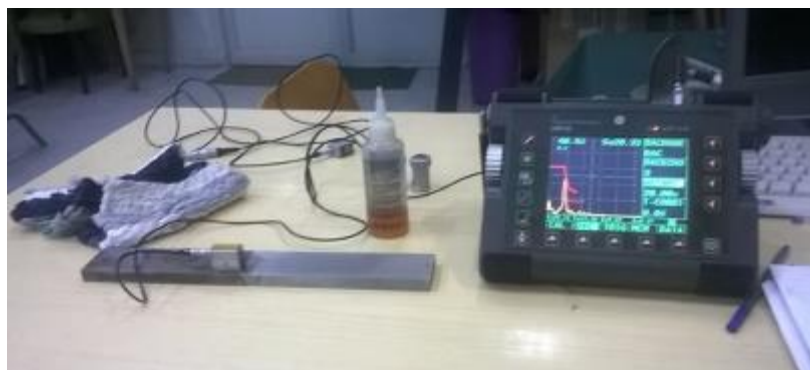
Fig. 5. Ultrasound testing of the samples

imperfections with a diameter of 3 mm were formed at a depth of 6 mm on the edge of the welding seam, in cross-section. The experimental stand used for the ultrasound testing; the reflected pulse method is presented in Figure 5.

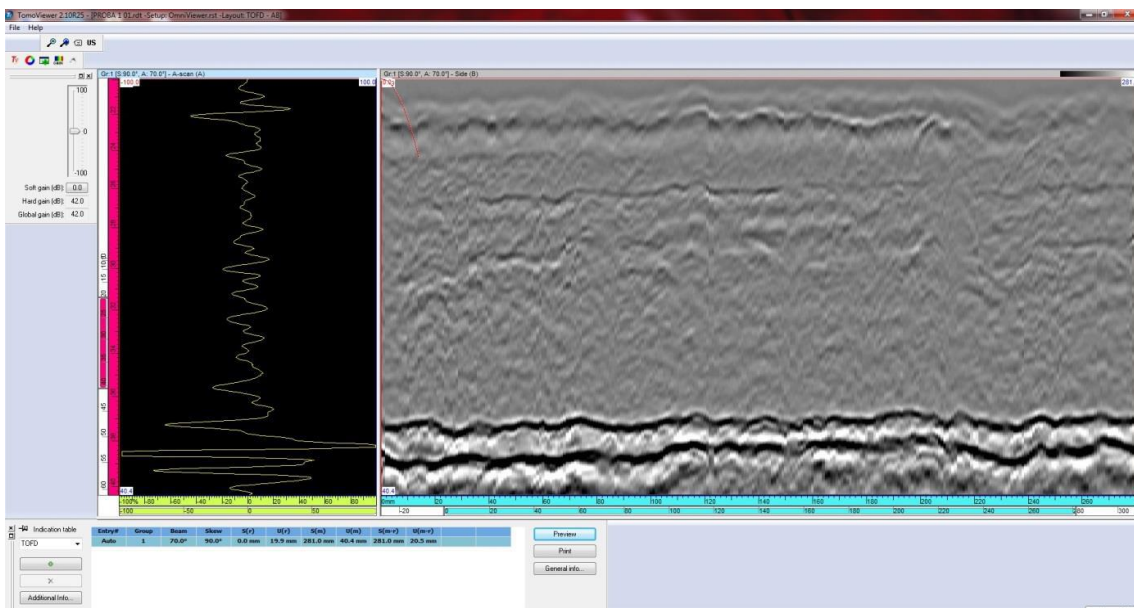
Fig. 7. TOFD report results

Subsequently the welded joints were subjected to ultrasound examination by the TOFD technique. In Figure 6 and 7 one of the TOFD report is presented.

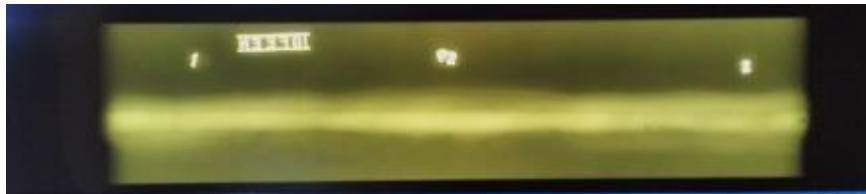
Fig. 8. Radiographic film-sample 2

There were no imperfections of the interior highlighted using the Radiographic Testing, result which attest to the quality of the welded joint, as it can be seen from Figure 8.

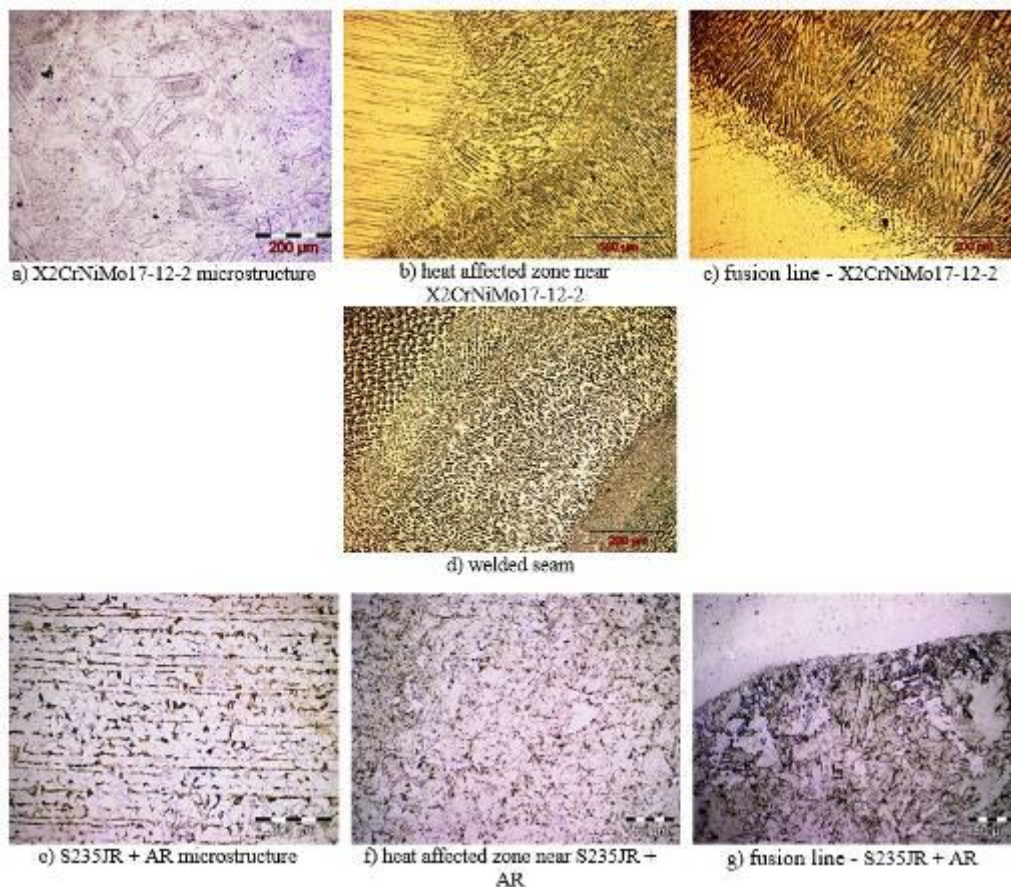
Fig. 9. Microscopic analysis

In order to analyse the microstructure obtained destructive examination was applied. In figure 9 is presented the microstructure obtained in the areas of interest, namely: the heat-affected area, the fusion line, and the welded seam.

- Stainless steel, X2CrNiMo17-12-2, shows microstructure with snail polyhedron grains and intragranular precipitations.
- Carbon steel, S235JR + AR, presents a ferrite-perlite microstructure in alternating ferrite and perlite strings.

- The fusion line between carbon steel, S235JR + AR (lower part), and deposition by welding with a high alloyed material (top). The HAZ shows the tendency to increase the granulation and the formation of the perlite and the coarse ferrite - Widmanstätten type.

- The fusion line between austenitic stainless steel, X2CrNiMo17-12-2, and welding with a high alloyed material. One biphasic ferrite and austenitic dendritic microstructure can be observed.

- In the heat affected zone near S235JR + AR a modified ferrite and perlite structure is observed.
- In the heat affected zone near X2CrNiMo17-12-2 a dendritic microstructure directed towards the direction of the thermal delta and austenite ferrite flow is observed.

- The welded seam shows a dendritic structure of delta and austenite ferrite.
