ANALYSIS OF THE WEAR PROCESS OF THE ELEMENTS IN THE BRAKING SYSTEM OF HEAVY TRUCKS

ABSTRACT

KEYWORDS: brake, wear, brake pads wear, brake disk wear

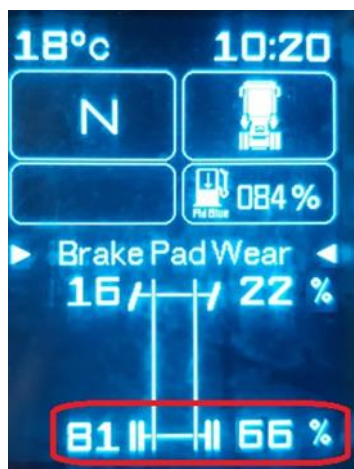
Fig. 1. Information provided to the user regarding the stage of wear of the brake pads

All these defects must be prevented in such a way that it is not possible to carry out the braking process while driving, so that there must be regular intervals of preventive inspection. More recently, electronic assistance systems have been used to monitor system parts. However, at present, the only maintenance system for the brake system is based on the information transmitted to the brake pad wear sensor display (Figure 1). Based on this, service interventions will be required to replace the brake pads when the electronic system alerts the driver.

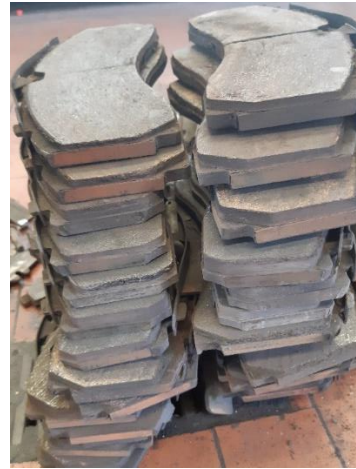
Fig. 2. Large volume of obsolete parts that do not have a recycling plan

Figures 2 and 3 show parts replaced during a calendar month in the repair shop where the analysis was performed. There is a very large volume of replaced brake pads and a few worn brake discs. Among the parts in both figures can be seen some that have not yet reached the degree of wear but are still replaced. These issues related to the premature replacement of some elements require a careful analysis both for the efficiency of the economic balance and for the identification of solutions for electronic monitoring and evaluation of wear elements in order to determine the exact degree of wear and use of resources as efficiently as possible.

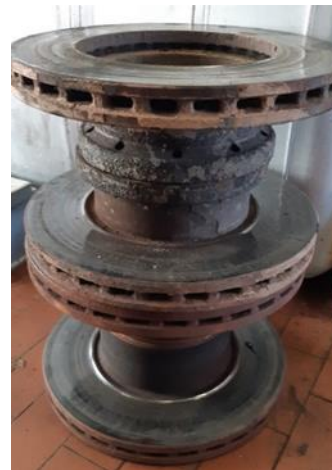
Fig. 3. Worn brake discs for which there is no recycling plan

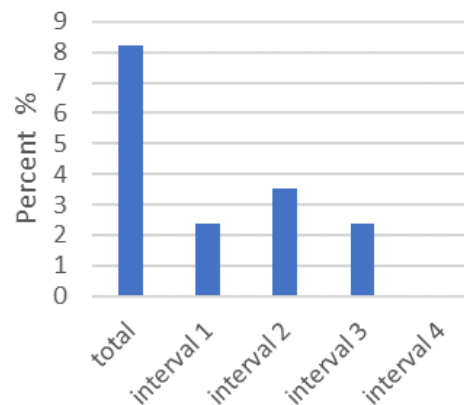
After analysing the wear intervals (by reading the values from the brake pad wear sensors), from the total number of trucks analysed, at 8.24% of them, at least a wear value greater than 99% was identified for one of the brake pads. The distribution of these cases (Figure 4) was analysed as in the other cases based on the current maintenance interval. As already mentioned, in the interval 4 the data cannot be completely analysed due to the large number of kilometres required to be covered until the beginning of the interval and then for the passage of the interval until the total wear. The "interval" represented the distance travelled between two brake pad replacements.

Fig. 4. Cases with wear greater than 99 %

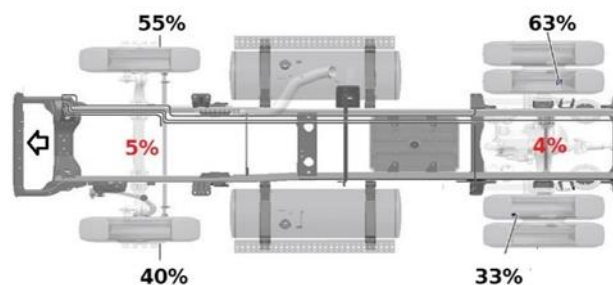
Fig. 5. Cases in which there is a greater wear of the brake elements on the right wheel

been significantly more cases with more wear on the right-hand brake elements. Figure 5 shows the percentages in which the wear was higher on the respective wheel and in the middle are the percentages in which the wear was equal to the wheels of the same axle (with an error of 1%). In 55%

of cases on the front axle and in 63% of cases on the rear axle there was more wear on the right side, while only in 5% of cases on the front axle and 4% of cases on the rear axle respectively, no there were differences in wear.

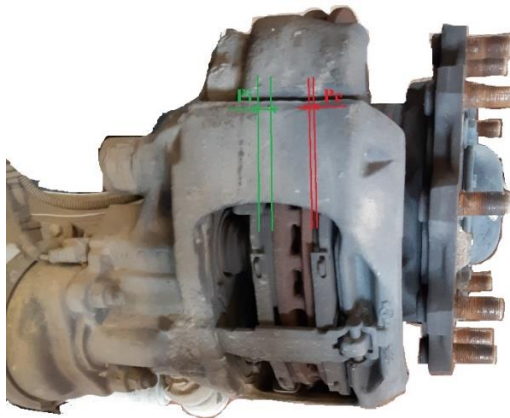
Analysing the shape of the wear, it was found that a determining factor for the premature replacement of the brake pads or discs is due to the uneven wear of the elements in the system. This can be either a different wear of the brake pad from the inside than the outside or another case can be due to the different wear of the pads on the wheels of the same axle. Figure 6 shows an example of different wear of the outer pad from the inside and Figure 7 shows the effect of different wear on the brake pads.

Fig. 6. Wear difference on the inner brake pad (Pi) compared to the outer brake pad (Pe)

In both cases of wear and tear, the cause of the wear and tear was the suppression of the calliper or the plate. Specifically, Figure 6 shows the locking movement of the brake pad from the outside relative

to its support, and Figure 7 shows the difference in wear between the left and right is caused by the locking movement of the left calliper on the bolts its. Without the calliper sliding, the braking on the axle was performed differently, which only led to the wear of the elements in the functional brake coupling. The operation of the calliper sliding system was discussed in the first part of the thesis. The translational movement of the calliper is absolutely necessary so that the pressing force of the pistons is applied uniformly on the surface of both brake pads.

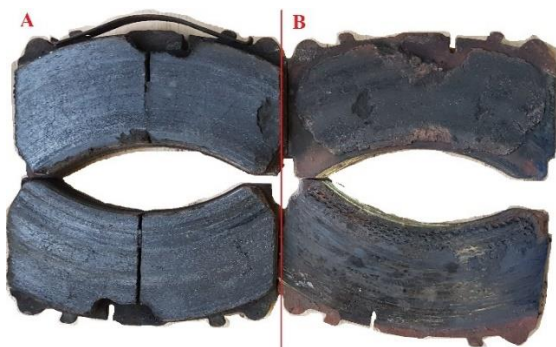
Fig. 7. Brake pads of the same axle, worn differently (A-left; B-right)

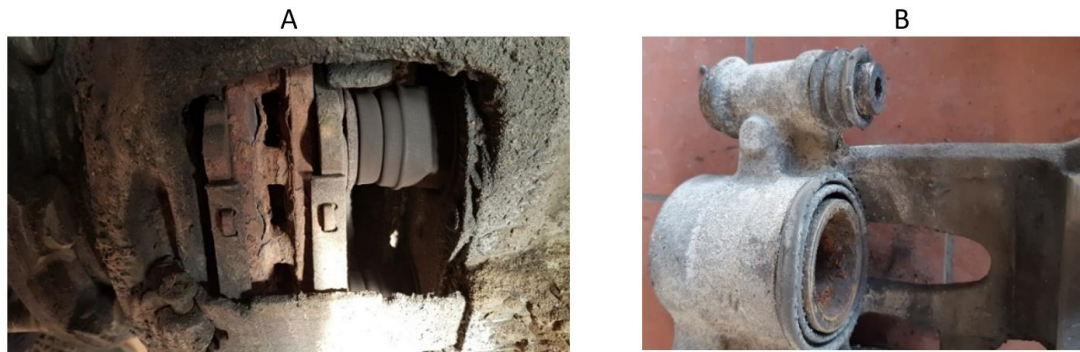
The analysis of the factors that favour these defects is an essential element for the improvement of the performances, at the same time as the reduction of the maintenance costs. Figure 8 shows one of the external factors that most frequently contributes to blocking the translational motion, namely deposits of dust, mud and other materials from the outside environment.

Fig. 8. Deposits and corrosion under normal working conditions A-deposits on the stirrup; B-deposits on the guide bolts of the brake calliper

Suppression of the friction torque elements is a common cause of premature replacement of parts in the system. During the study it was found that although there is a complex maintenance system, this type of defect is not monitored electronically. Such a brake calliper position and movement monitoring system would be useful in this regard but would bring additional costs to the system. In this case, the question is whether these additional costs are lower than the damage caused by defects and whether a cheap system could be implemented to streamline the process.

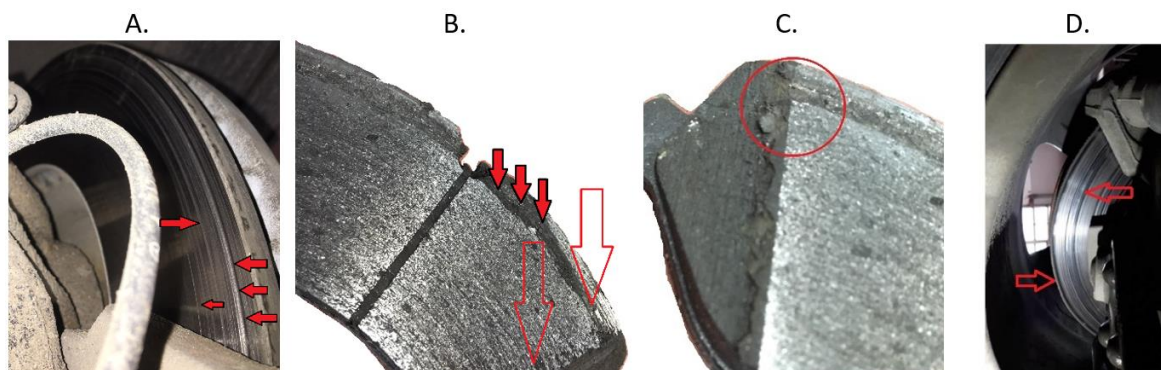
During the analysis, a series of defects were identified caused by impurities from the external environment, the presence of which favors abrasion wear. In addition to the influence of abrasive materials from the outside environment, corrosion is also a major problem because there are a number of common factors that influence wear and tear and significantly reduce the life of the elements in the braking system. The combination of several types of wear based on common influencing factors generates defects such as those in Figure 9.

The main effects of the situations shown in Figure 9 lead to increased degradation and premature decommissioning of the pads and (in most cases) brake discs, leading to a significant increase in maintenance costs. As a side effect of these types of wear, there are a number of specific noises (rumble or sharp noises). The intensity and type of these noises significantly affect the quality of life in areas close to roads. At the same time, these noises are the main warning about the occurrence or existence of a fault.

Fig. 9. Combined effects of the influence of impurities and particles from the external environment on the wear of the brake discs and pads: A, D- the effects of abrasive wear on the brake disc; B, C- degradation of the brake pads under the action of external factors and corrosion

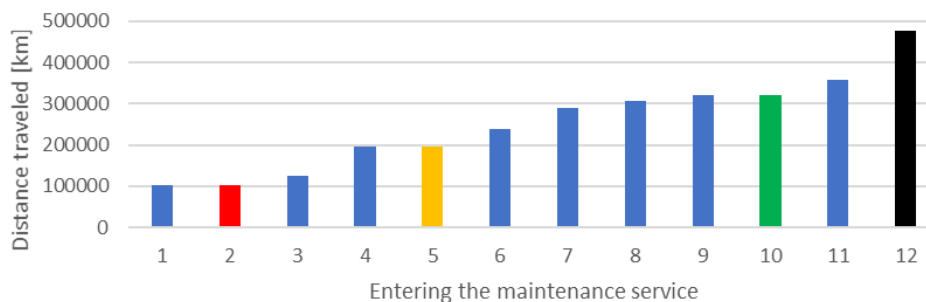
Figure 10 shows the situation of another truck without an auxiliary braking system, which is running in internal traffic but which already has up to 477 000 km and has 4 brake pad replacements. This is a significant justification for the need to use auxiliary braking systems. During the work, several cases of accentuated wear of the elements in the braking system were found and frequent thermal overloads of

the brakes were frequently identified with serious effects on the braking performance. It has also been found that when heavy wear occurs or in cases of thermal overload, repair costs increase significantly and, in most cases, it becomes necessary to replace the brake discs. The current study also contains an economic analysis of these maintenance costs for certain cases but also a part of the analysis of the effects of thermal overloads on the elements of the braking system.

Fig. 10. Distribution of service entries and replacement of brake pads on the front axle to a truck without an auxiliary braking system

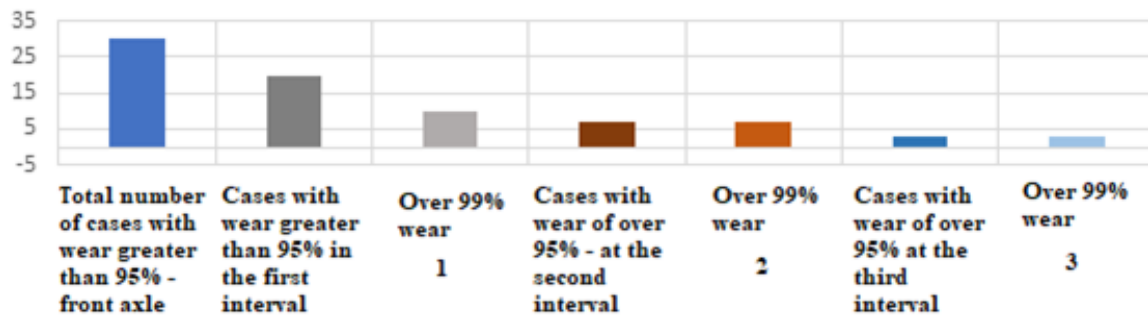
The graphs in Figures 11 and 12 show the distribution of cases with wear greater than 95%. The degree of wear is read from the data taken from the brake pad wear sensors.

It is observed that both the front and the rear axle have a high weight in cases where the wear is higher than 95%. The technical documentation provided by the manufacturer recommends replacement from 90% (even 85% in some cases) so further use from values above 95% is not recommended. Above these values, the rate of serious defects increases exponentially, so the continued use is not only no longer justified but also with much higher risks.

Fig. 11. Distribution of wear cases close to the maximum limit for the front axle

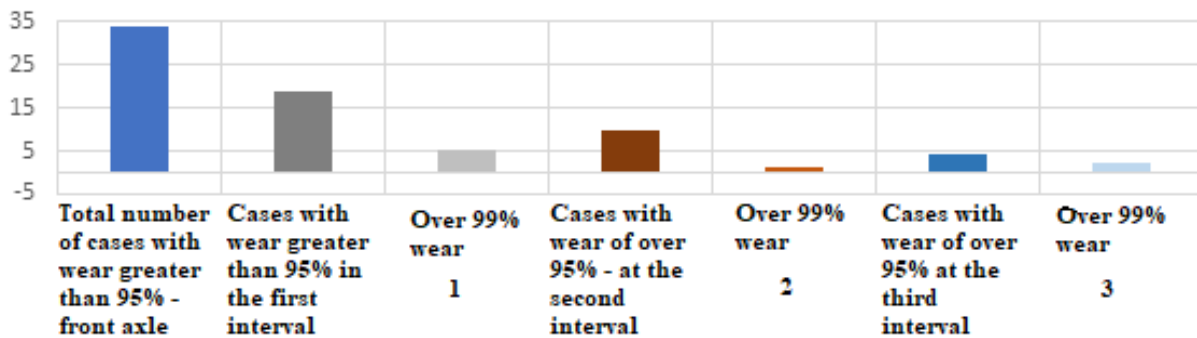
Fig. 12. Distribution of wear cases close to the maximum limit for the rear axle

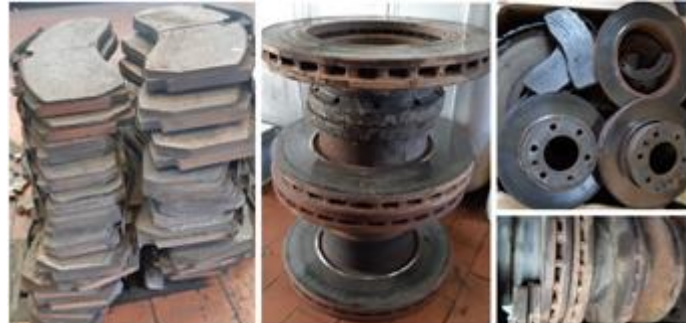
Figure 13 shows the parts replaced during a calendar month in the repair shop where the analysis was performed. There is a very large volume of replaced brake pads and a few worn brake discs. Among the parts, you can see some that have not yet reached the degree of wear but are still replaced. These issues related to the premature replacement of some elements require a careful analysis both for the efficiency of the economic balance and for the identification of solutions for electronic monitoring and evaluation of the elements of wear in order to

Following the analysis of the problems encountered in operation on commercial vehicles, it was found that in addition to the problems of wear and defects, these vehicles also generate a large volume of waste resulting from the parts used. This aspect needs special attention, especially in the ecological context of environmental protection. In this sense, a major regulation of these situations would be useful, especially since these used parts are generated, as it was found, in quite large quantities (Fig. 13).

Fig. 13. The problem of used parts that generate a large volume of waste and for which there is no recycling plan
