ADVANCED METHODS TO CHARACTERIZE THE STRUCTURAL MATERIALS OF RELIGIOUS BUILDINGS CONSTRUCTION

ABSTRACT

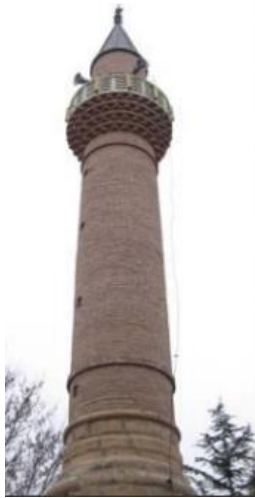
1. Hacı Mahmut Mosque, which is situated in the charming town of Bolvadin, which is a part of the Afyon province in Turkey. The minaret stands independently on the north-east corner of the mosque, and boasts of an octagonal base that is almost as tall as the outer wall of the mosque itself. The minaret stands tall at an impressive height of 24.5 meters. The transition from the pulpit to the shaft is achieved through the skilful use of moldings with circular surfaces. The shaft itself is circular and extends all the way up to the balcony, which is supported by a base made up of similar moldings with circular surfaces. The balcony, in turn, is fashioned in the form of a parapet. The cylindrical comb, with a diameter smaller than the shaft, culminates in a metallic spire that adds to the allure of the minaret. Constructed using brick and stone masonry, the minaret has a total of 76 concrete boarding steps at its center, Fig. 1.

Fig. 1. General view of *haci mahmut mosque* [1]

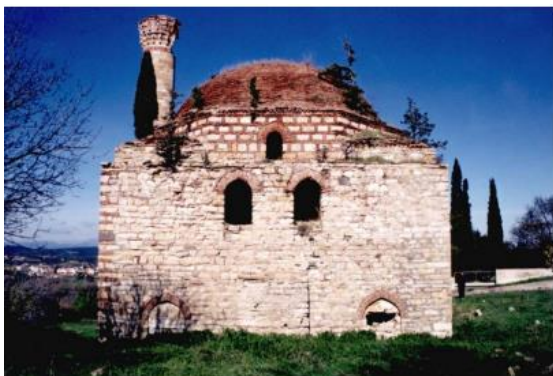
The structure has a square plan of 10 x 10 m, a wall thickness of 110 cm, and a height of 12.66 m. The dome and the window arches are brick masonry with thick mortar joints, while the walls of the structure are stone masonry with thick mortar joints and limestone. Utilizing squinches, which are brick masonry elements depicted in Figure 2, is a technique employed to achieve the seamless transition from walls to dome on the corners of historical structures.

Fig. 2. South elevation view of the mosque [3]

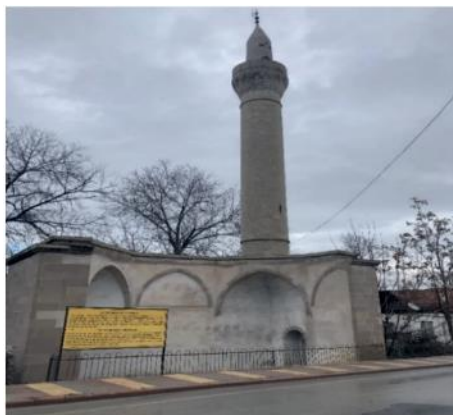
4. The Sütlü Minaret Mosque is an exquisite example of Ottoman architecture, characterized by a singular dome that adorns its silhouette (as depicted in Fig. 4). Situated beyond the city walls of the Battalgazi District in the City of Malatya, this mosque is steeped in historical significance. The edifice derives its name from its striking appearance, which evokes the imagery of "milky" hues. The mosque's pristine white facade, crafted from stones that retain their lustrous colour, is a testament to its enduring elegance and aesthetic appeal. The mosque is quadruple fronted and has an elevation in the west-east direction. The entry to the mosque is located on the west side facing the road.

In the initial survey, it was detected that two different types of stones were used in the construction, and the walls inside the building were completely covered with plaster. The wall is built with coursed rubble stones approximately 180 cm from the ground. The minaret of the mosque is approximately 21 m tall, and the body of the minaret has a diameter of 162 cm. The pulpit has a stone

Fig. 4. The overall perspective of the Historical Sütlü Mosque [5]
