**THE ANNALS OF  
“DUNAREA DE JOS”  
UNIVERSITY OF GALATI**

Fascicle IX  
**METALLURGY AND MATERIALS SCIENCE**

YEAR XLIV (XLIX)  
June 2026, no. 2

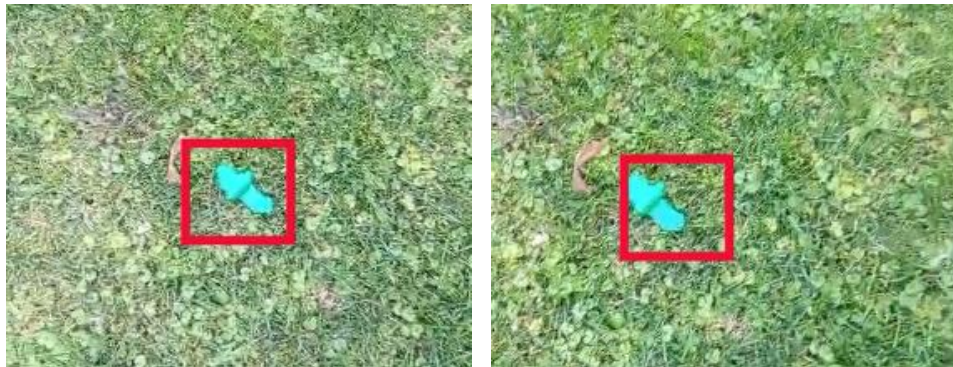
**Fig. 2.** Camouflaged 3D-printed PFM-1 in vegetated scene and corresponding DCDN segmentation result

segmentation performance consistently above 90% IoU under most evaluation conditions. These findings confirm the suitability of deep camouflage-aware architectures for detecting low-contrast 3D models in visually homogeneous environments while maintaining a computational efficiency compatible with real-time processing constraints. A qualitative example of the segmentation output is illustrated in Figure 2.

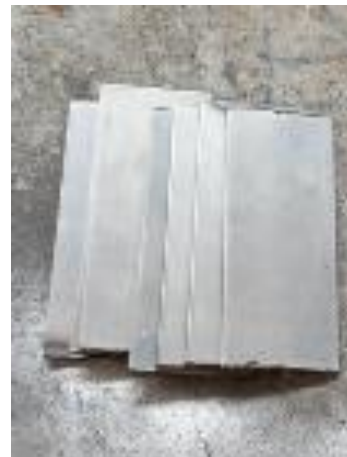
**Fig. 3.** Specimens in the form of rectangular plates before the hot forging process

In the experimental process of preparing the specimens (Damascus steel), plates in the form of rectangular shapes (see Fig. 3) with dimensions of 2 x 40 x 100 mm were used. These were alternated to obtain packages of 30 layers each, which, by free forging/hot hammering, resulted in the knife blade shown in Figure 4 [14, 15].

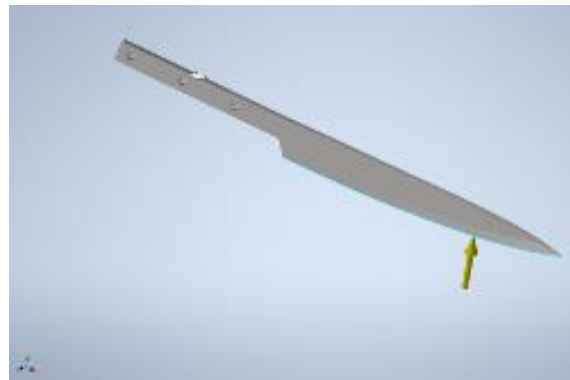
**Fig. 5. Selected testing face, corresponding to the specimen**

In the first step, the test side of the knife blade and a fixed constraint (the knife handle, the right part) are selected. In Figures 5 and 6, the selected testing face [15] and the fixed constraint are shown.

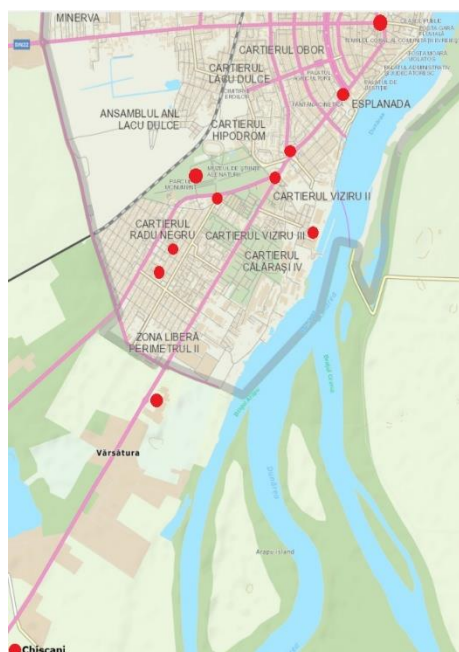
Fig. 2. Snow sampling locations mapped in Brăila [7]

The study was conducted in the municipality of Brăila, located in southeastern Romania, which is characterized by a temperate continental climate with cold winters favourable to snow accumulation [6]. To highlight the spatial variability of urban pollutants, four types of functional areas were selected:

- High-traffic areas: The Dorobanților Blvd.–Calea Călărași intersection; the Buzăului Road–Vizirului Road intersection; the Calea Călărași–Independenței Blvd. intersection; the Historic Centre; and a shopping centre parking area (Vărsătura);
- Residential areas: The Radu Negru neighborhood – one sample collected from a yard and one from the street;
- Industrial areas: The Chiscani chemical platform and the Brăila Shipyard;
- Green spaces: Monument Park – one sample collected from the interior and one from the park entrance (Buzăului Road).

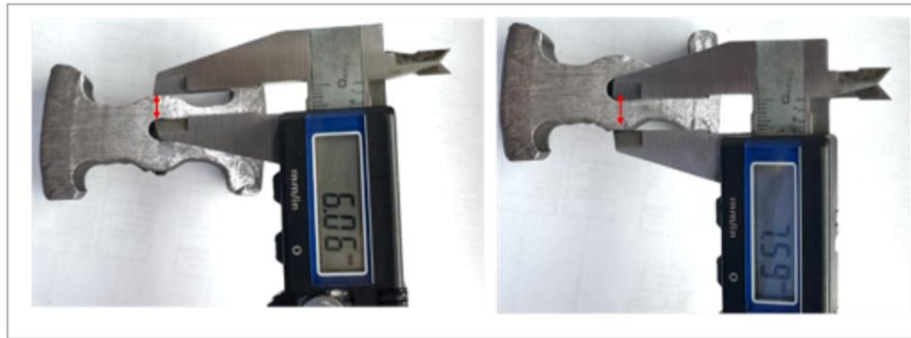
Differences in thickness from the Central Squirt (Oil) hole

(a difference of 1.53 mm). The asymmetric material distribution, highlighted by the digital vernier calliper readings (Figure 3), reveals a notable thickness difference on either side of the central oil hole.

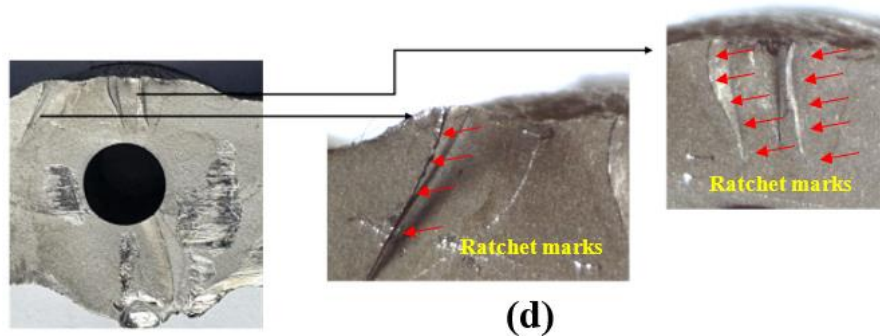
A fractographic analysis of the failed connecting rod was performed, focusing on the fracture surface characteristics observed around the central oil hole and corners of the broken end. The investigation highlights signs of fatigue crack initiation, progression, and final fracture, providing insight into the failure mechanism and likely origin.

**Fig. 4.** Surface fracture: (a) left side, central side (b), right side (c), and magnified view of the crack origin (d)
