AN ANALYSIS OF THE DYNAMICS OF THE ENVIRONMENTAL PARAMETERS IN THE ROMANIAN NEARSHORE OF THE BLACK SEA

Dragos NICULESCU ^{1), 2), *}, Eugen RUSU ²⁾

¹⁾ National Institute for Marine Research and Development "Grigore Antipa", Department of Oceanography, 300 Mamaia Avenue, 900581, Constanța, Romania

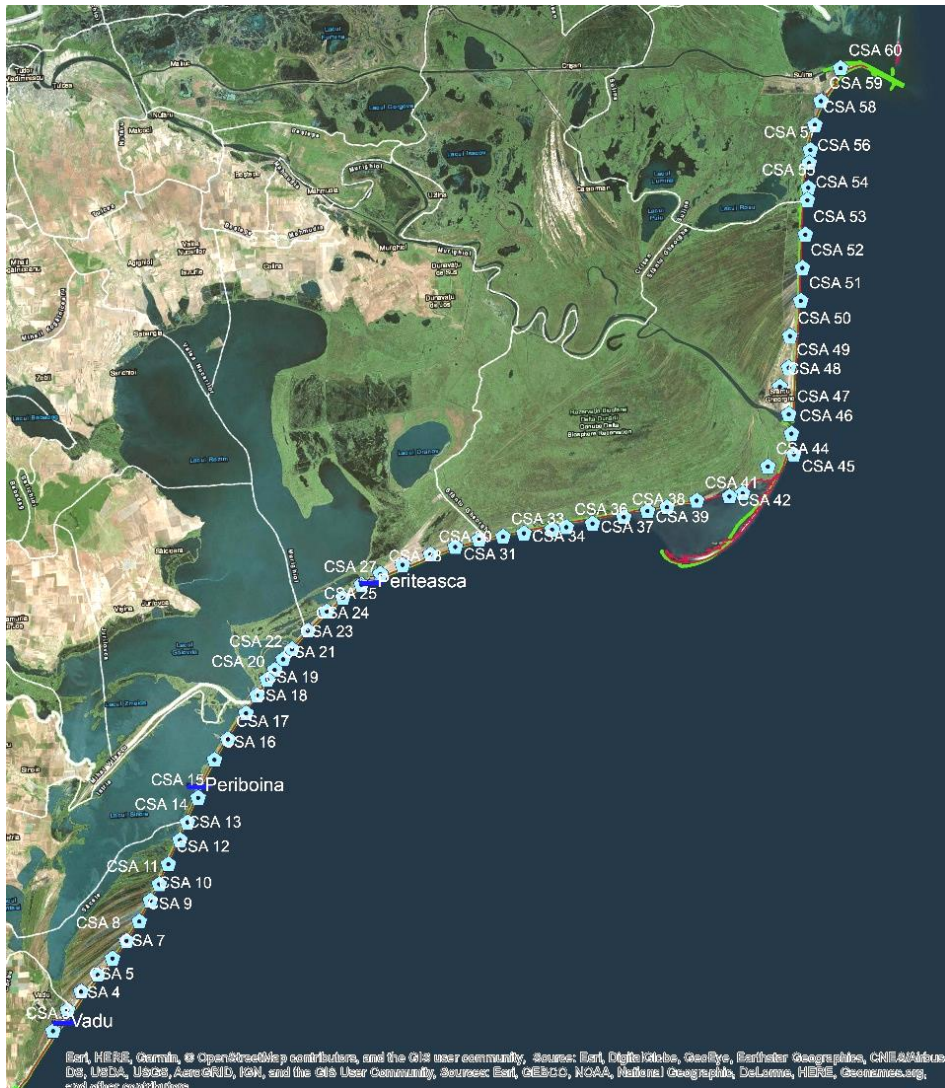
Fig. 1. The landmark topographic system on the Northern Romanian Littoral, as installed in 1961

The erosion processes and its extension along the Romanian Black Sea coast have been observed since 1962. The study is based on a topographic network of concrete landmarks, which span about 140 km in length and were distributed along the shore in the Northern Sector in the Danube Delta Biosphere Reservation, in 1961 (Fig. 1). In the Southern Sector, the monitoring started in 1980, after the first topographic network was installed in this area [3].

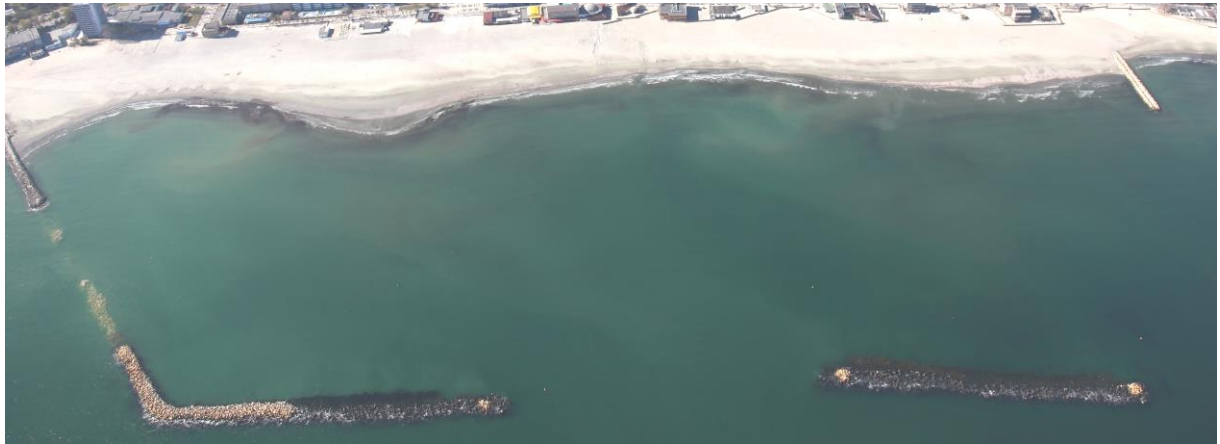
Fig. 4. Dike reconstruction and beach nourishment in the south of Mamaia resort

In the erosion process, an important role is played by the wind that generates the waves and, if the wind would blow in a certain direction for a long period of time, it can change the surface current direction [6], [7]. Several studies have been done on the subject of coastal protection by modelling wind, waves, currents and sediment transport along the coast, in order to provide a better understanding in what spots should the protective dikes be built and what would their impact be on the coastline [8], [9], [10], [11]. The new dike system and sand nourishment were implemented in 2015, in several spots along the Romanian coast, like South Mamaia Resort (Fig. 4), Constanta coastline (Fig. 5) and Eforie Nord coastline (Fig. 6).

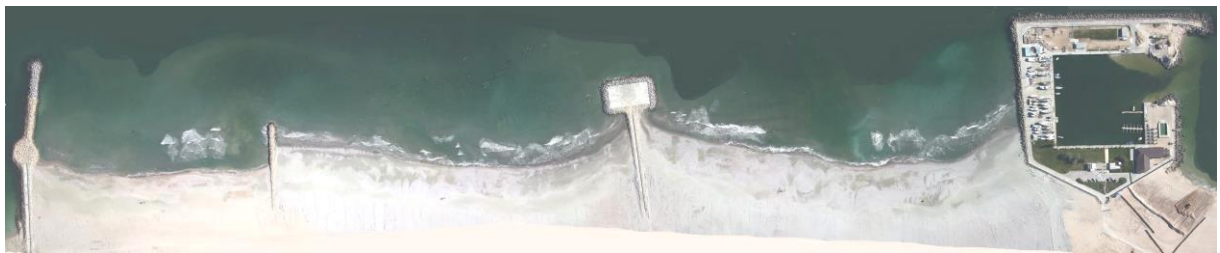
Fig. 5. Dike reconstruction and enlargement alongside with beach nourishment in Eforie North

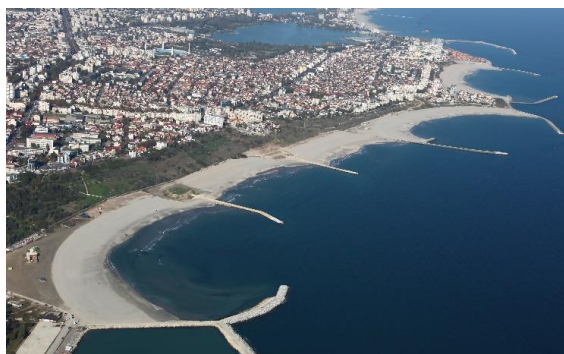
Fig. 5. New dike system constructed and beach nourishment at Constanta

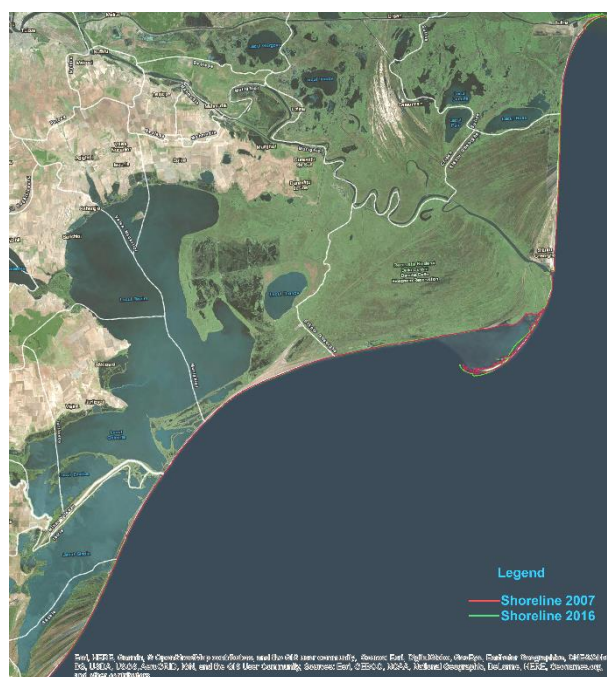
Fig. 6. Shoreline modifications between 1962 -2012 a) and 2007 – 2016 b)

The shoreline measurements/mapping are done annually if possible with GPS instruments that are in a GIS class, but for the maps in this paper only three shorelines were used, from 2012 for the one in Fig. 7 a) and 2007 with 2016 Fig. 7 b).

A comparison between the shorelines from 1962/1985 to 2006 and 2017 shows the rhythm of evolution between the two periods (Fig. 7). This also gives some visual information about how the shore looks. In general the difference is small as the period between the two shorelines are not far apart only 11 years. Because the Masterplan was finalized during this period the regions where the sand nourishment was done are significantly greater (IPJ 5 to IPJ 2) from the normal shoreline evolution.

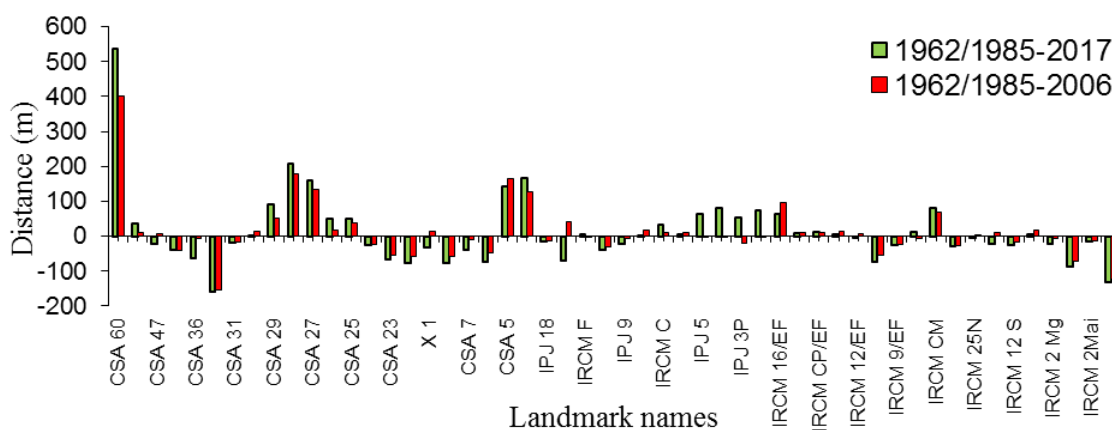
Graph 1 – Accretion and erosion values along topographic network for two time periods

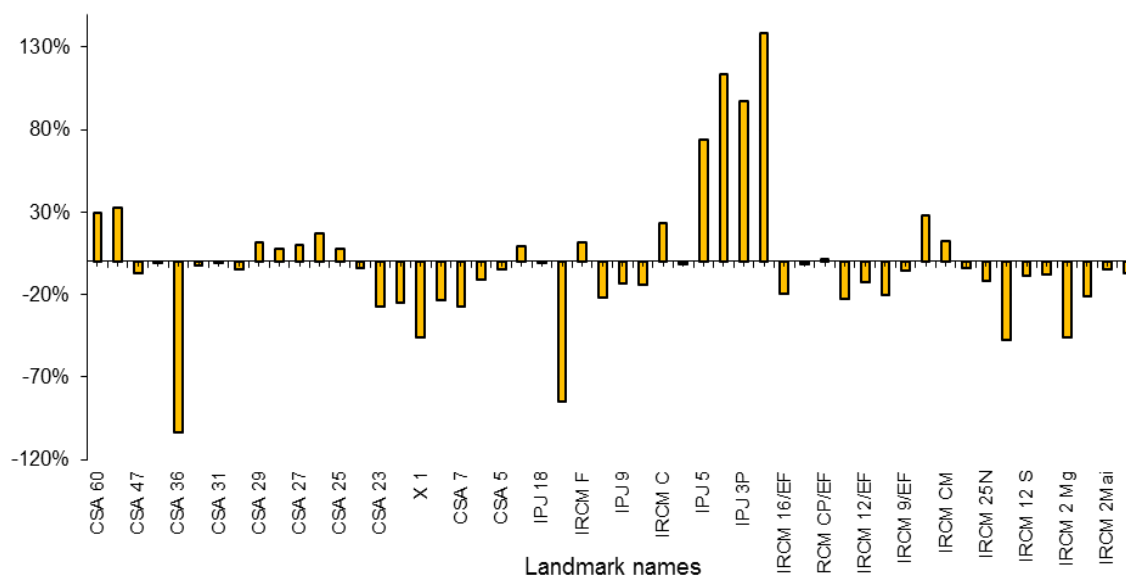
Graph 2 – Percentage result between the two time periods

Fig. 8. Evolution of the shoreline

In the second graph (Fig. 8), the percentage difference reflects, as an even better perspective, the natural evolution of the shoreline, from the artificial sand nourishment. In the northern part the first two topographic references, a 30% accretion have been seen, which is equivalent to 135.3 m or approximately 12 m/year, for the first one and 24.7 m or 2.2 m/year for the second one. There are also two extreme cases where the shoreline retreated 104% (CSA36 or Ciotica – Perisor sector) and 85% (IPJ 15 or northern part of Mamaia) in these 11 years. The rest of the coastline was subjected to natural conditions.

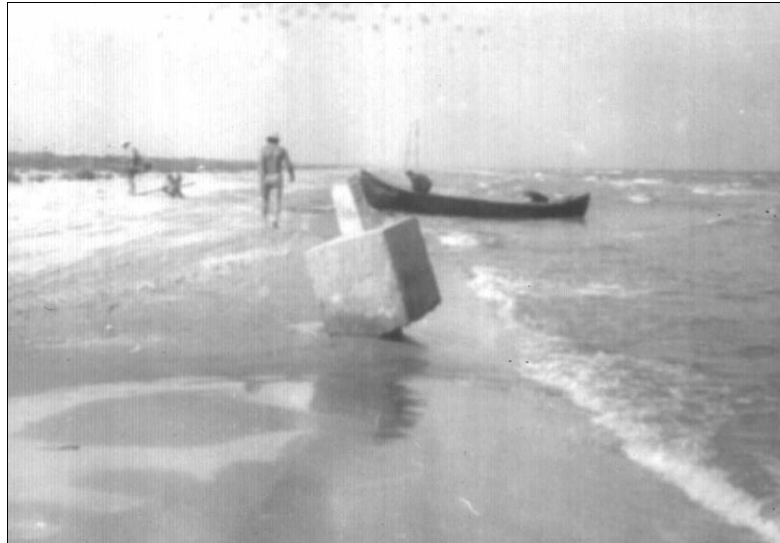
The CSA 51 landmark in the photo is taken in 1983, 11 years after it was installed, nowadays the landmark is not in use because is in the sea (Fig. 9).

Fig. 9. CSA 51 landmark in the surf zone
