INFLUENCE OF COOLING OIL ON THE SURFACE QUALITY OF THE ROLLED STRIP

Tamara RADU, Stela CONSTANTINESCU, Florentina POTECAȘU

"Dunarea de Jos" University of Galati, Romania e-mail: tradu@ugal.ro

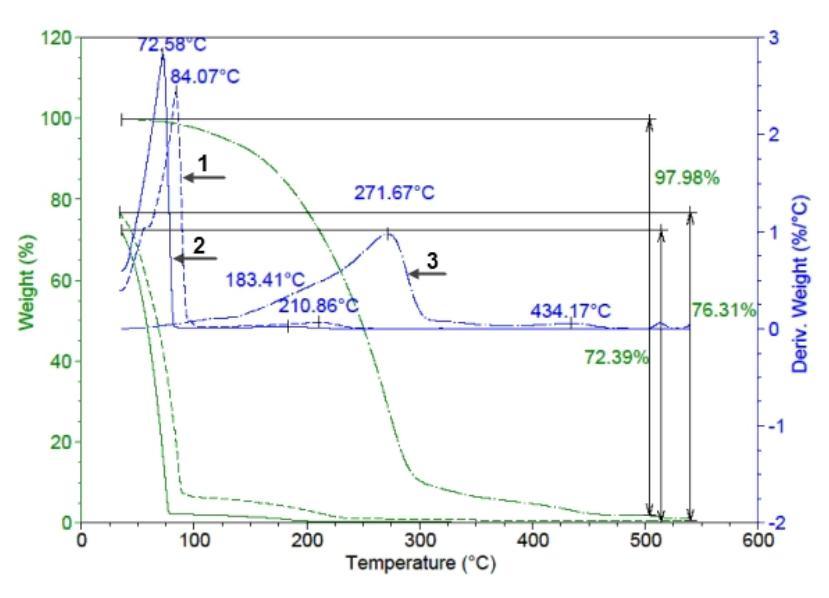
Fig. 2. Analysis of emulsion stability according to temperature 1 – used emulsion; 2 – fresh emulsion; 3 – mineral oil

For clean emulsion (oil 4.5% and water), mass loss is 76.31%. A temperature of 72.58 °C corresponds to the maximum kinetics of water evaporation. The next inflection is at 183.41 °C and corresponds to the maximum kinetics of lubricating oil mass loss. At temperatures above 200 °C, no mass losses are registered. For used emulsion two transformation temperatures were observed, and a total mass loss of 76.31%. A temperature of 84.07 °C corresponds to the maximum kinetics of the water evaporation process and a temperature of 210.86 °C corresponds to the lubricating oil. At temperatures above 350 °C mass losses are insignificant.
