## SURVEY AND REHABILITATION OF THE DRY-DOCK MAIN FLOATING GATE

*The paper is a theoretical and practical approach to the uncommon way of rehabilitation of the dry-dock main gate of Damen Shipyards Galați. Most of the water tight system of the gate being under water and considering the improper condition of work in the Danube water, the taking out of the gate bottom became a must. The applied method considered the gate inclination of about 90° under floating status by particular actions based on theoretical calculation.*

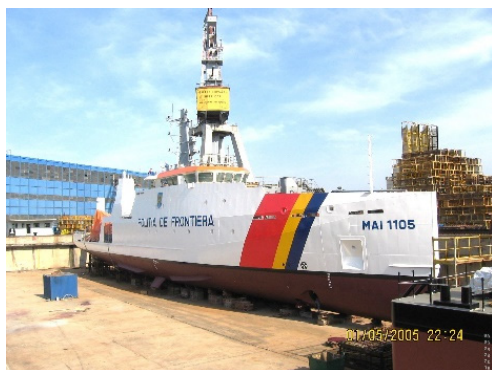
Ship in the dry-dock

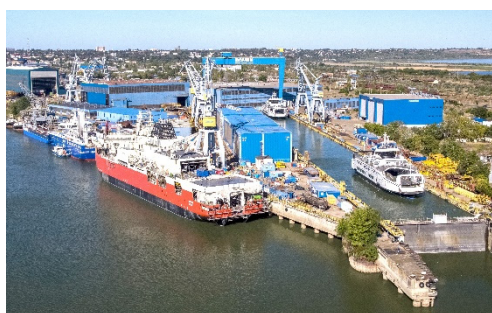
The launching of two ships

As the hull building platform is higher than the average Danube level (+4.1m), it was a must to chose the lock-system dock. The dry dock consists of two components, i.e. the ship construction chamber and the ship launching chamber. Filling both chambers with water at + 10.0m level allows the launching the ship (Figure 1, Figure 2). The floating main gate provides the separation and tightness between the dock level and Danube level.

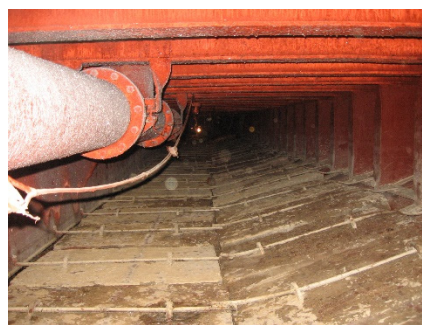
**Fig. 15** Narrow space in double bottom

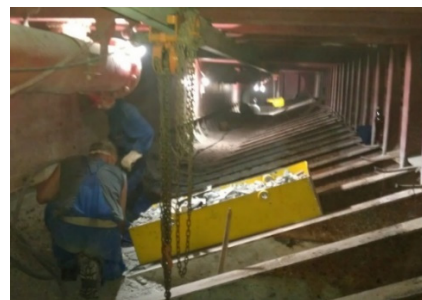
**Fig. 16** Pick-hammering the concrete

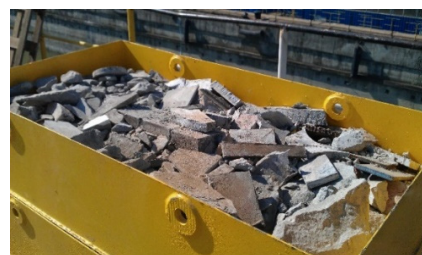
**Fig. 17** Debris container

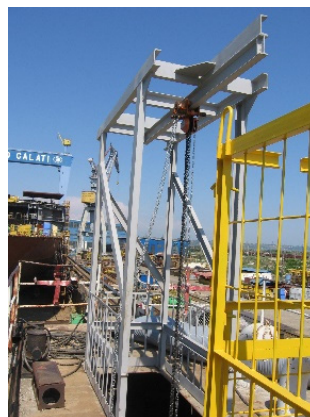
**Fig. 18** Discharge of concrete

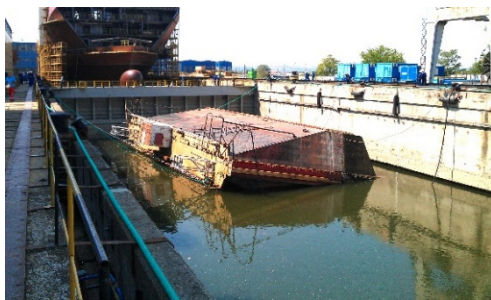
The following photos show the **heeling of the gate**:

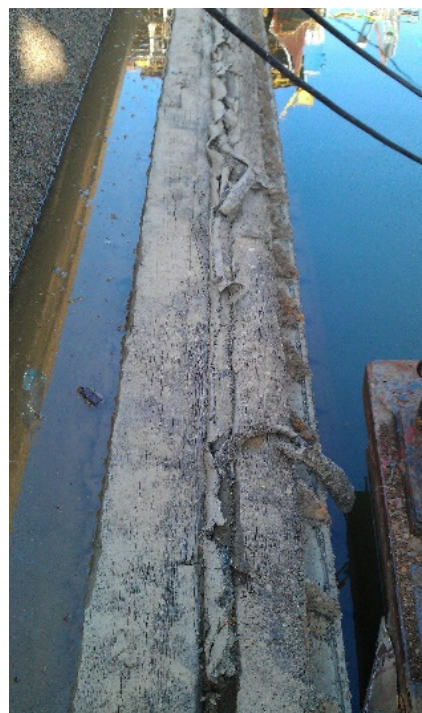
The survey confirmed the wear out of the sealing gasket (Figure 27, Figure 28):

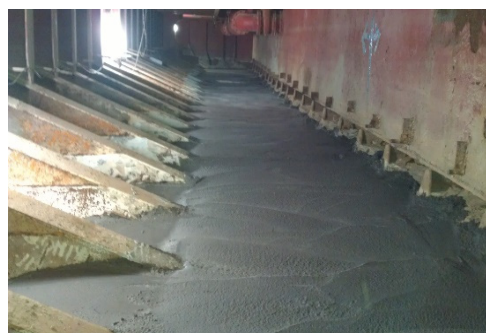
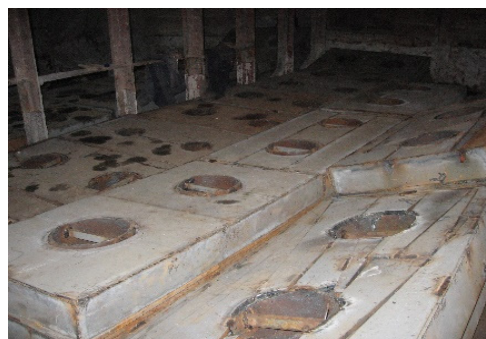
The photos below show the double bottom after solid ballast completion (partly poured, partly with removable packages)

- The completion of the solid ballast with 275 tons only, against the removed 410 tons;
- A new ballast tank "0" with the capacity of 417 tons was created to cover the gap of 135 tons between the original ballast solid quantity and the new quantity;
- The arrangement of the additional tank "0" system, designated to ballasting (via tank no.1 by remote operated valves) and de-ballasting by pumps.
